Massive intercostal hemorrhage after implantation of an intrapericardial ventricular assist device: a case report

James Etheridge¹, Ryan Cousins², and Jonathan Philpott³

September 11, 2020

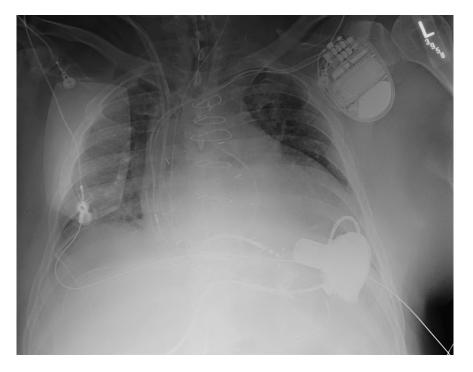
A 54-year-old man with end-stage ischemic cardiomyopathy was admitted to our center for LVAD placement. Echocardiography revealed a left ventricular ejection fraction of 10% with an end-diastolic dimension of 8.5 cm. He was approved for a HeartWare HVAD (HeartWare International, Framingham, MA), which was placed in the standard apical position via median sternotomy (Figure 1). A polytetrafluoroethylene (PTFE) membrane was placed over the pump housing and outflow graft, as is our usual practice. Hemostasis was achieved quickly, and no intraoperative complications were noted. Postoperatively, the patient complained of severe left-sided chest pain despite appropriate analgesia. This was attributed to poor pain tolerance and his narcotic dosing was increased. No evidence of trauma or significant effusion was found on serial chest radiographs; however, the pump housing appeared to contact the chest wall in several films.

Figure 1.? Postoperative chest radiograph showing the HeartWare HVAD device (HeartWare International, Framingham, MA) in the apical position. The pump housing appears to be closely apposed to the chest wall.

The presence of a rib fracture at this site suggests that the pump housing can exert substantial force on adjacent structures. As such, a diaphragmatic position should be strongly considered in the setting of significant left ventricular dilation or massive cardiomegaly, particularly in a thin patient. If the standard apical position is used, a high index of suspicion must be maintained for chest wall trauma. Ultrasound or two-view chest radiography should be used to assess for injury if there is significant left-sided chest pain, and any evidence of hemodynamic compromise should trigger immediate consideration of surgical bleeding.

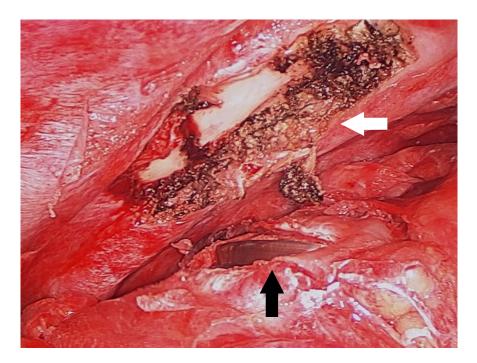
In this case, several factors suggest that hemorrhage resulted from sustained contact between the pump housing and the chest wall. Iatrogenic rib fractures from median sternotomies are not uncommon and could certainly lacerate intercostal vessels. However, there was no excessive spreading during this procedure, and postoperative chest radiographs demonstrated no evidence of fracture. External cardiac massage can also result in rib fractures, but the intercostal hemorrhage clearly preceded chest compressions. Rather, we observed obvious erosion of the pump housing through the overlying PTFE membrane and pericardium. This aligned perfectly with the injured segment of the chest wall.

Figure 2.? Internal view of the left hemithorax during exploration. The pump housing has eroded through the PTFE membrane and pericardium (black arrow), and the overlying rib is fractured and denuded of periosteum (white arrow). Bleeding from the intercostal artery has been controlled with electrocautery.
