# An unusual cause for inappropriate defibrillator shock.

**Short title:** Late ICD lead perforation leading to defibrillator shock.

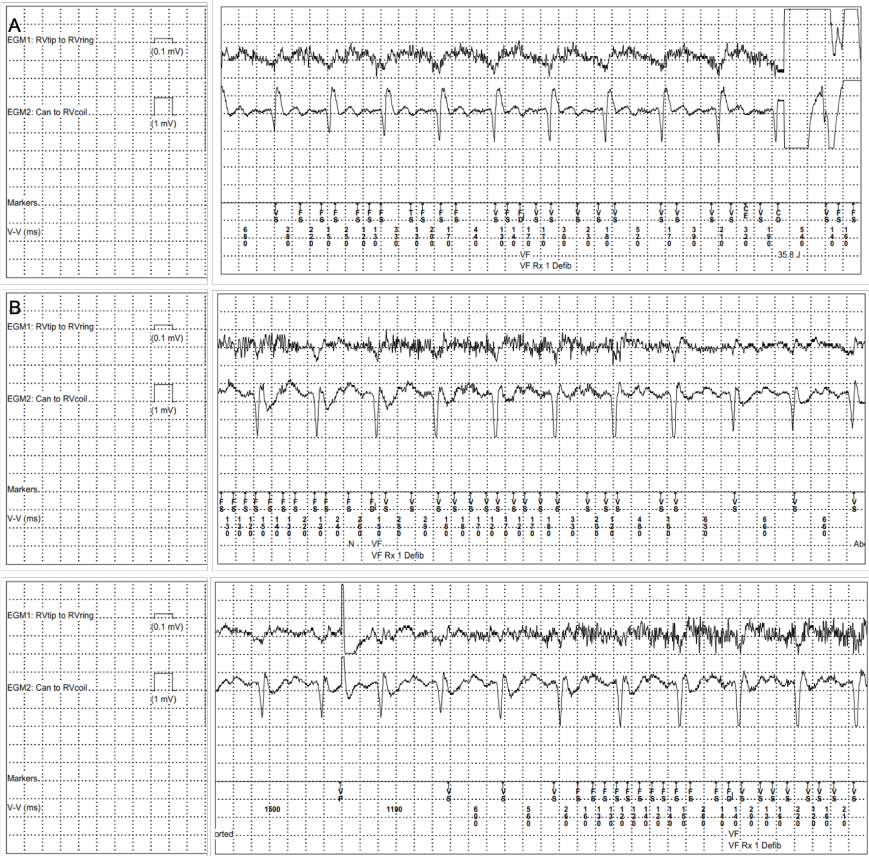
1. There is more noise in the near field (NF, tip to ring) than far field (FF, Can to coil). In fact, there is hardly any QRS / clear electrogram in NF in spite of 10 times more magnification of NF electrogram [0.1 vs 1 mV scale].
2. The oversensing in the marker channel is intermittent although there is background noise throughout. As the intensity of background noise varies, the oversensing varies simultaneously, making it intermittent in the marker channels.
3. The characteristic of the noise (which is clearer in panel 1B) is like myopotential (high frequency, low amplitude) as compared to make and break signals of lead fracture (high frequency and high amplitude).

Myopotential appears to be the most likely possibility as per the high frequency, low amplitude uniform nature of the noise. Both pectoral and diaphragmatic myopotentials (DMP) are non-cyclical but can have variation of the noise related to arm movement / respiration respectively. However, pectoral myopotential tends to have more noise in FF / leadless EGM as the IPG (Can) is nearby [1,3]. As ICDs do not use FF signals as default sensing channel, pectoral myopotentials do not lead to oversensing ( unless the sensing polarity is manually changed) [2]. In the index case, NF predominant noise indicates oversensing related DMP. Real time EGM during deep inspiration also confirmed the same.

Fig 1A: Stored electrograms of the treated episode in the VF zone. It shows oversensing of noise dissociated from the native QRS.

Fig 1B: The lower 2 panels are continuous tracings from another recent episode where the therapy got aborted as the noise amplitude became below the RV lead sensitivity. The lowest panel also shows undersensing and inadvertent RV pacing after the 2<sup>nd</sup> QRS complex. The LOC could be true or functional.

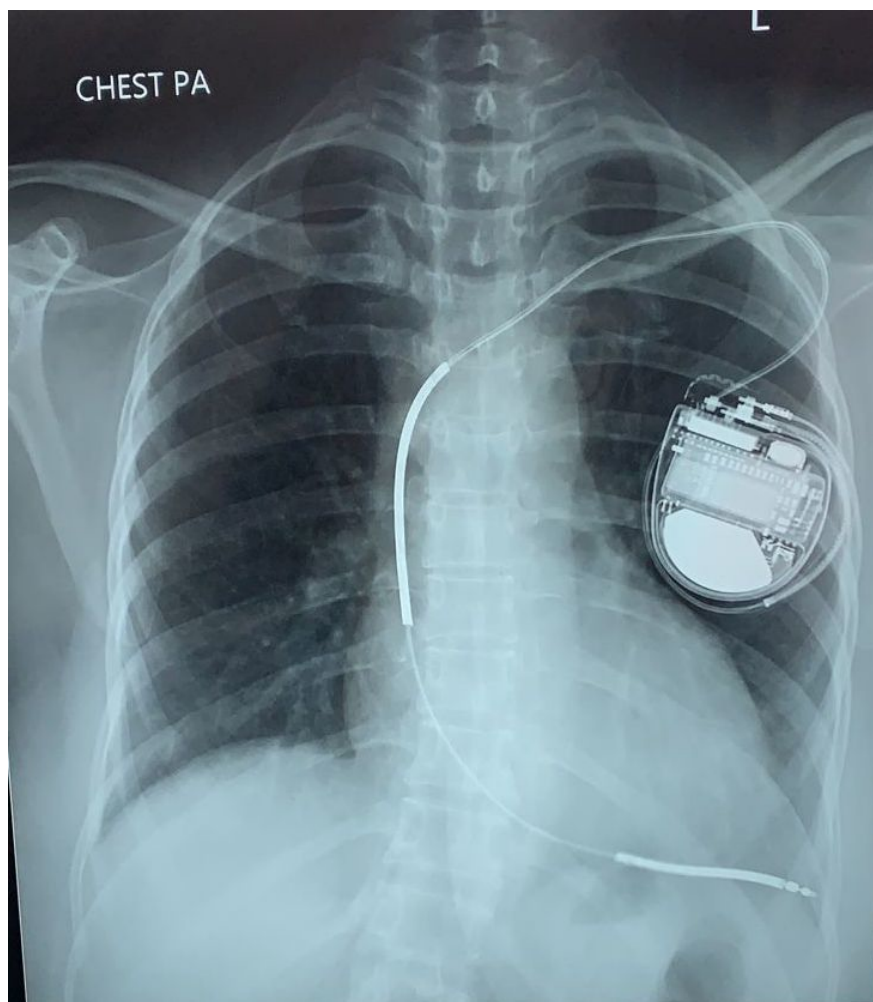
Our case had dedicated bipolar lead without pacing requirement, hence, perforation was suspected upfront. However, echocardiography did not show any pericardial effusion. The lead could be traced only upto the apex. But the device parameters were grossly abnormal. R wave amplitude (sensing) was < 1mV and loss of capture (LOC) was evident even at highest output. In fact, the lowermost panel in Fig 1 shows undersensing along with LOC (true / functional) in the Vp beat. Interestingly, pacing and shocking impedance trends were all within normal range. Finally, chest X ray (CXR) and fluoroscopy confirmed a lead perforation as the lead was noted outside the cardiac silhouette almost reaching the inner chest wall (Fig. 2).

Fig 2: Preoperative chest X ray showing lead beyond cardiac silhouette suggestive of perforation

After explaining the scenario to the patient's relatives, she was scheduled for lead extraction in a hybrid operation theater (OT). In the OT under general anesthesia, the lead was unscrewed and pulled out. Luckily no evidence of pericardial effusion/ tamponade was noted on intraoperative trans-esophageal echocardiography (TEE). After waiting for 10 min, a new single coil ICD lead was positioned into lower-mid septum on the same sitting. Perioperative period was uneventful. To summarise, this unique case describes one of the rarer causes of inappropriate ICD discharges. This case also highlights the need for careful implantation ICD leads which being heavier and stiffer, have more preponderance for perforation than softer pacing leads.
