# Erosion Rates on Newly Uplift Marine Terraces Following the 2016 Kaikōura Magnitude 7.8 (Mw) Earthquake

November 22, 2022

# Erosion Rates on Newly Uplifted Marine Terraces Following the 2016 Kaikōura $M_w$ 7.8 Earthquake

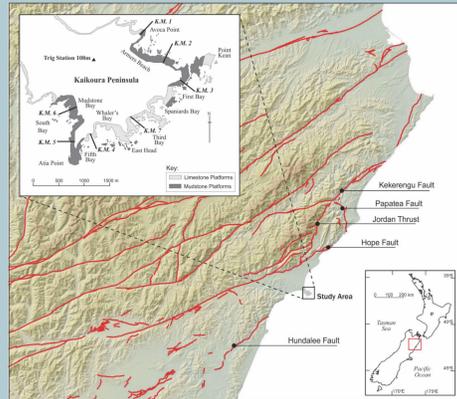
Figure 1. Location of major faults in the upper South Island, New Zealand and Kaikōura Peninsula showing location of MEM profiles and Trig station. Named faults are some of those that ruptured during the November 14 2016 earthquake (Langridge et al. 2016; Stephenson et al. 2017; Litchfield et al. 2018).

Since 1973, micro-erosion meters (MEM) have been used at Kaikōura Peninsula, New Zealand (Fig 1) to determine lowering rates on inter-tidal shore platforms. Rates measured over two, two year periods (1973-1975 and 1994-1996) and at decadal scales (20-30 years) demonstrate that platform surface lowering is on average 1.1 mm/yr. The 14 November 2016  $M_w$  7.8 Kaikōura earthquake caused an instantaneous uplift of 0.8-1.0 m of the peninsula (Fig. 2). The uplift offers the rare opportunity to examine how such an event alters processes and rates of erosion on these shore platforms (Fig. 3), since these platforms are now partially marine terraces as the inner margins of platforms are now above high tidal levels (but perhaps not storm surge, Fig. 3). Here we report 21 months of erosion monitoring since the earthquake, with a view to establishing the longevity of the newly uplift surface and the altered erosion rates on the shore platforms.

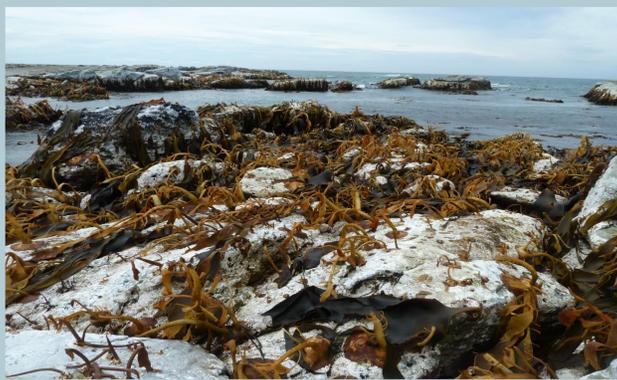
Figure 2. Seaward edge of a raised shore platform. Holdfasts of bull kelp (*Durvillaea antarctica*), previously located in the subtidal zone (18/12/2016).

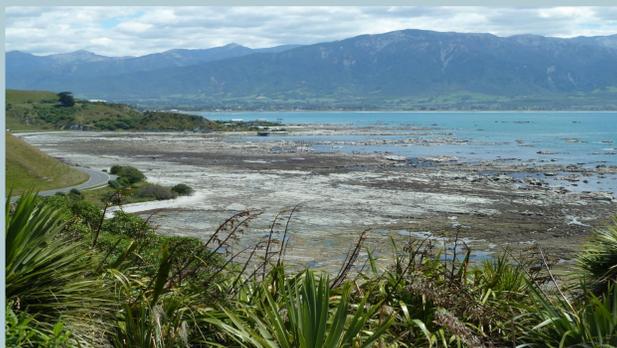
Figure 3. View of a raised and inter-tidal shore platform. North side of Kaikōura Peninsula. Profile KM2 (see Fig. 5), crosses centre of platform (18/12/2016).

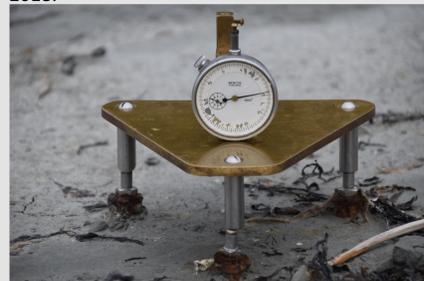
Figure 4. The Micro-erosion Meter, used at Kaikōura since 1973 (Kirk, 1977). The MEM sits atop three bolts installed in the rock (KM2B). Note these sit above the surface, when installed these were recessed. Evidence of the long term lowering of the surface.

Surface lowering on shore platform have been measured using the MEM (High and Hanna 1970). The MEM It comprises an engineering dial gauge attached to an equilateral triangle base, with three legs. The instrument sits atop three bolt permanently installed in the rock surface and precisely relocates using an Kelvin Clamp. The base is rotated 120° three times and the three readings are averaged, this average is then converted to a mean annual erosion rate (or swelling) for the site. The bolt sites were installed in 1973 on 6 profiles around the Peninsula and a seventh profile was added in 1993 (Fig 1.). Five profiles are located on Oligocene mudstone and two on Paleocene limestone. These profiles were resurveyed in December 2016 to determine the amount of uplift based on static GNSS observations (Stephenson et al. 2017). Since the earthquake, 45 MEM sites have been measured seven times at 3 monthly intervals. Most recently in September 2018.

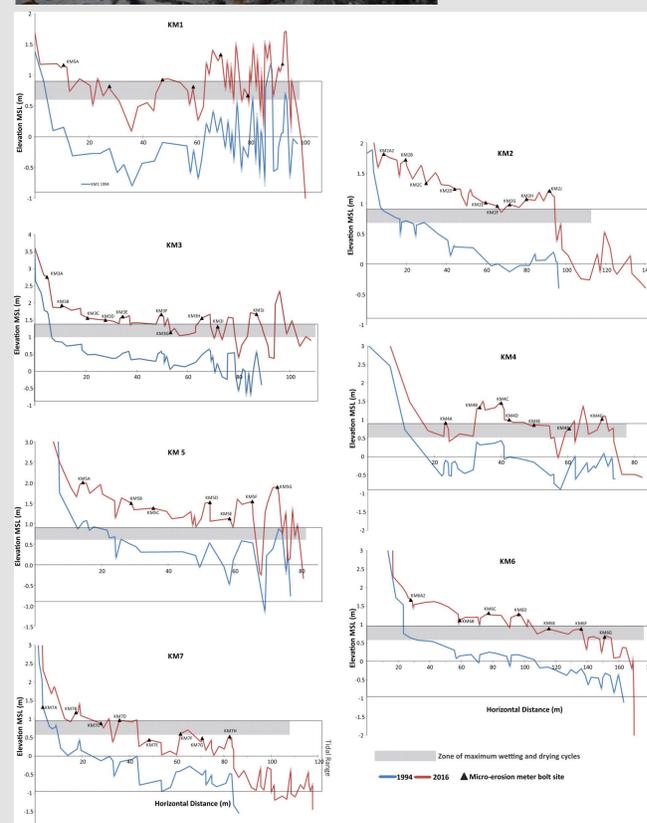
Figure 5. Surveyed platform profiles at Kaikōura and locations of MEM bolt sites. The blue profile was surveyed in 1994 and the red profile in December 2016, 4 weeks after the earthquake, following  $\approx 1$  m of uplift. Grey zone – elevation of maximum wetting and drying (Stephenson et al. 2017).

The coseismic uplift has altered the process regime operating on these platforms. Zones of maximum wetting and drying have migrated seaward causing previously slow eroding (< 1 mm/yr) MEM sites to accelerate to 2.5 times the pre-earthquake rates. Erosion rates demonstrate rapid adjustment of the platform surface to this disturbance and illustrate how uplifted marine terraces can be rapidly eroded despite being above sea level. Based on the uplift of 0.8 to 1.0 m and assuming a constant lowering rate of 2.5 mm/yr, the new marine terrace could be removed within the next 320-400 years (not accounting for backwear). Preservation of the new terrace is dependent on further uplift beyond the reach of the sea, within that timeframe. Furthermore the amount of terrace preserved will depend on the timing of that uplift within that time frame. This scenario has significant implications for marine terrace preservation and the recording of coseismic events in the landscape. Since the erosion rates we have measured show that newly uplift surface can be rapidly removed from the landscape and there is potential for the record of coseismic uplift to be lost.

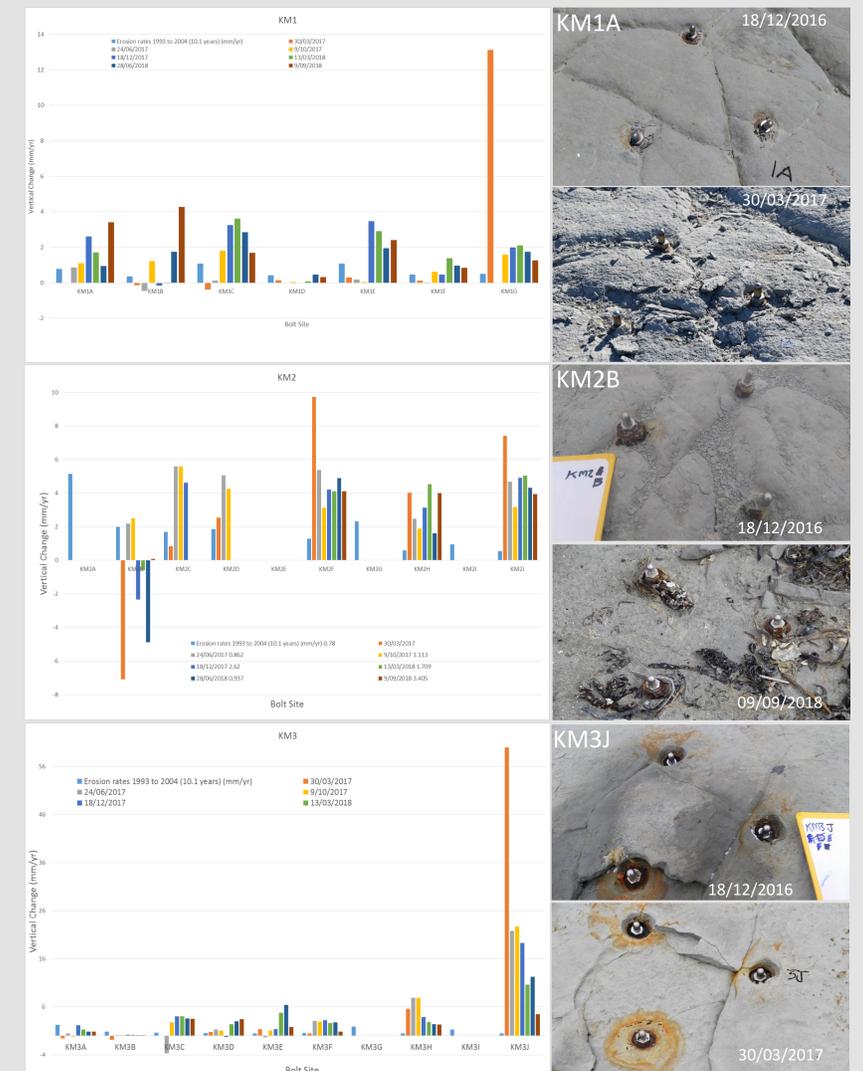
Figure 6. Erosion and swelling rates from three mudstone profiles at Kaikōura; KM1, 2 and 3. Cross shore variability in rates at each measurement period is evident. Side panels illustrate variety of surface change; rapid breakdown KM1A; erosion, swelling then burial of site KM2B; and larger scale block removal KM3J.

Mean erosion rates (mm/yr) at each measurement period by profile are shown in Table 1. These are compared to pre-earthquake rates from 2 (1993-1996) and 10 years (1993-2014). Mean rates mask highly variable inter-survey rates at individual bolt sites. Figure 6 illustrates this variability for three of the seven profiles, where both surface lowering and swelling are shown. Illustration of that variability are shown in the photo panels of Fig. 6. Rapid break down is evident (Fig 6A.), as is swelling and burial as weathered debris accumulates on the surface (Fig 6B), then larger scale (cm rather than mm) break down is evident in Fig. 6C. Erosion rates from before the earthquake were compared to those after using nonparametric tests of median distribution. Table 2 shows that these significantly different, with different means and distributions.
