Space Based Assessment and Review of Chamoli, Uttarakhand (North India) Rockslide Event of February 07, 2021

Chandra Mohan Bhatt, Pratima Pandey, Praveen K Thakur, Arijit Roy and Prakash Chauhan

Indian Institute of Remote Sensing (IIRS), ISRO, Dehradun, India

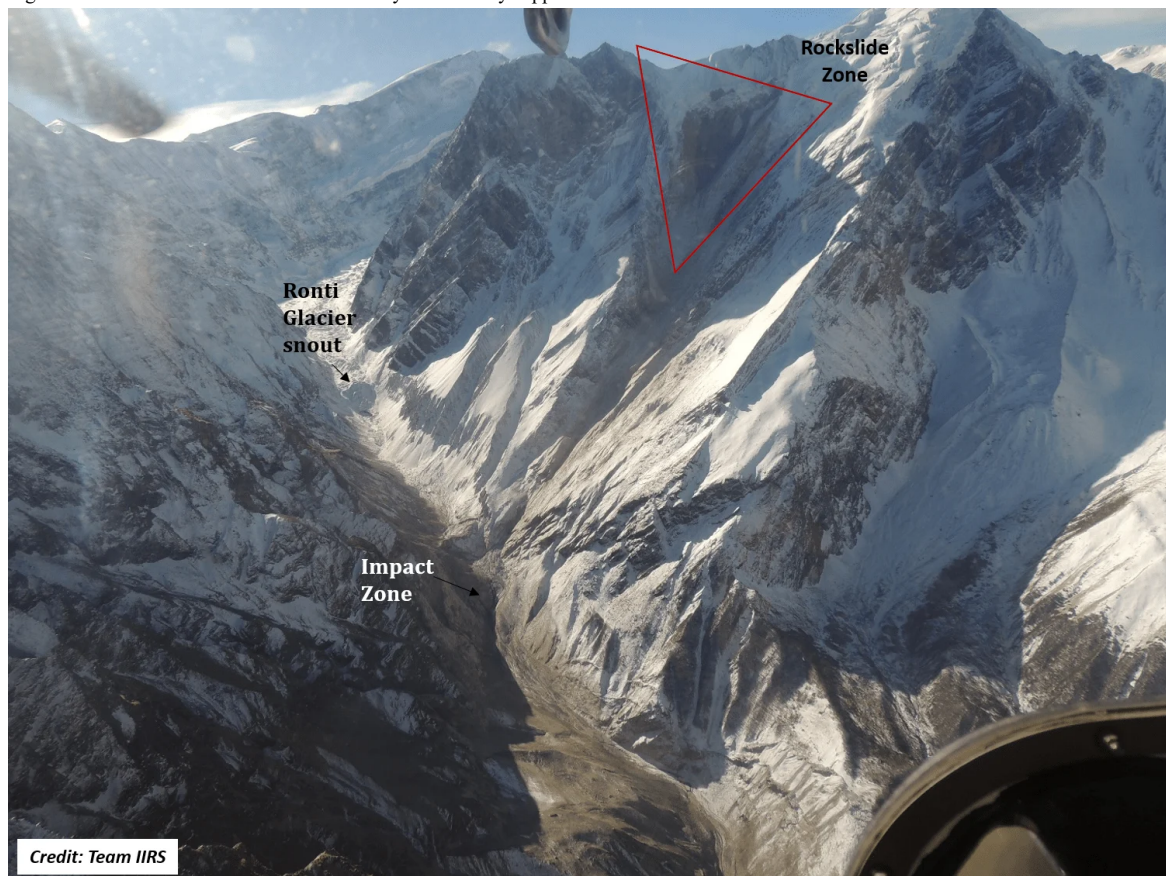
Figure 5a Wedge failure zone

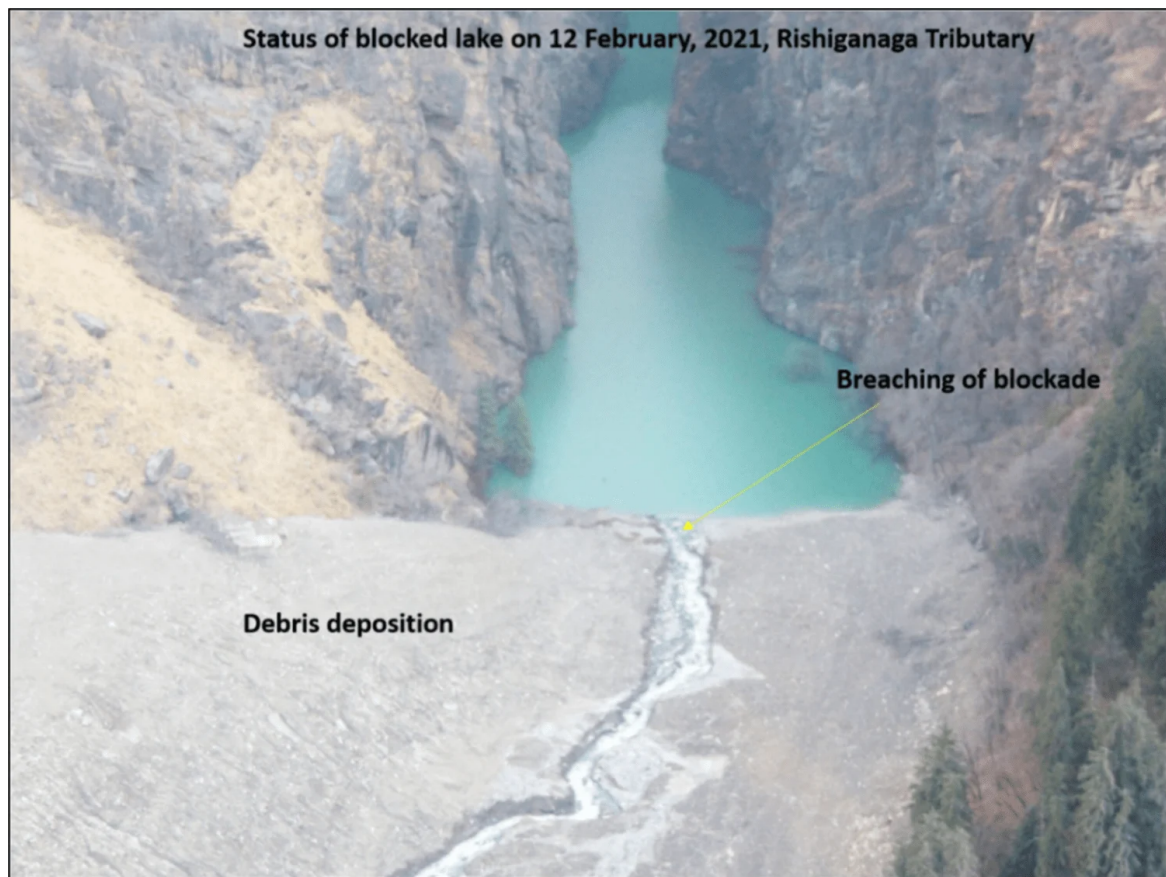
Figure 5c Channel impoundment
