Extensive Post-Seismic Cover-Collapse Sinkhole Opening During 2020–2021 Petrinja Earthquake Sequence (Croatia): a Unique Local Geological, Geotechnical and Hydrological Setting

November 22, 2022

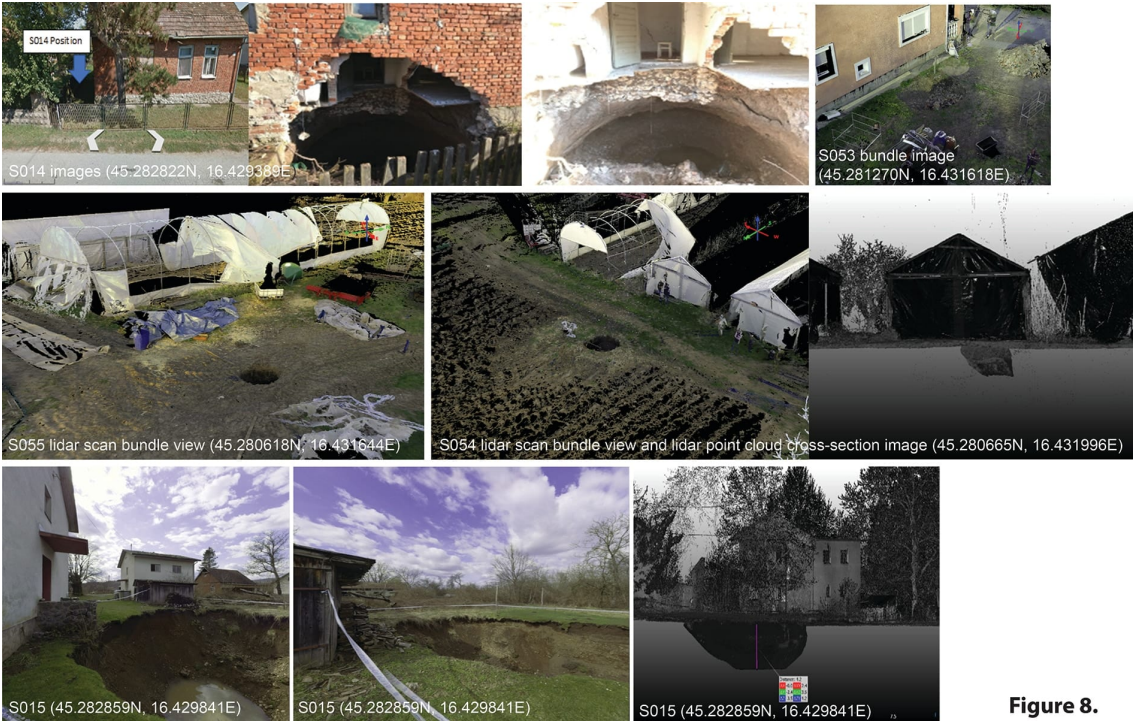
Figure 8.

A few sinkholes caused significant infrastructure damage. Although the two villages' area is predominately agricultural, some homeowners survived dramatic collapses under their houses, in the proximate vicinity, or on their farms. Farmland remained drastically damaged with >100 sporadically placed sinkholes, and some occurred near greenhouses. Cover-collapse sinkhole S015, 12.1 m length, 9.4 m width, 3.5 m depth, collapsed between two houses on December 29, 2021, following the mainshock earlier on the same day. Two smaller sinkholes, each approximately 1 m in diameter and 1 m deep, opened six hours after the main earthquake, then combined into a large sinkhole within the next 12 hours. S054 (1.6–2.0 m in diameter, 1.3 m deep) and S055 (1.5 m in diameter, 2.3 m deep) caused significant discomfort and distress to the people residing on the neighboring farm. S054 and S055 are circular sinkholes with small diameters, quite deep, and have vertical walls (Figure 8).
