# Agricultural Defense of São Paulo: twelve years of soil preservation and rehabilitation at Rio do Peixe watershed, promoting conservation agriculture

## Abstract

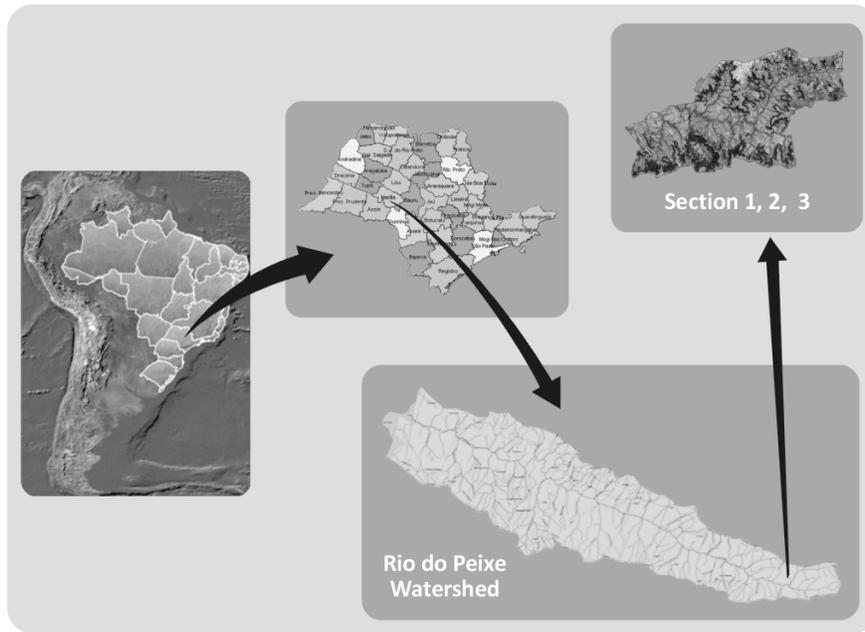
This work was carried out in the stretch of the Rio do Peixe watershed (Rio do Peixe watershed), located in Vera Cruz, Ocaçu and Marília, SP, Brazil, under coordinates S22°14'52.68", W49°44'59.97", start and end under coordinates S22°18'13.28", W50°2'54.22", Datum WGS 84 (Figure 1). The climate of the region is the humid subtropical of the Cwa type, according to the Köppen classification, with temperatures in the warmest month above 29.7°C and in the coldest month, below 10.6°C, with rainfall annual average of 1,193 mm. The predominant soils are Red-Yellow Ultisol, Abrupt, moderate horizon A, sandy/medium texture and Litolic Entisol, eutrophic (Santos et al., 2018). The geological formation consists of rocks from the Bauru Group, covered by neocenoic sediments (Bezerra et al., 2009). The predominant relief is smooth-undulating, in the western plateau of São Paulo and, in the region of the depression, it is strongly undulating in the escarpments (Itambé) that separate the plateau from the depression.

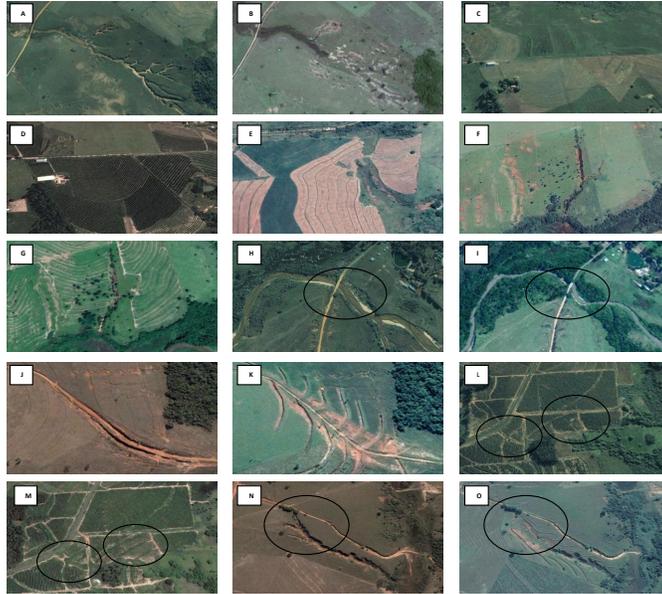
The results obtained with the changes in soil and water conservation management practices regarding the improvement of vegetation cover were confirmed by the evaluation of aerial images before the study was carried out - 2002 - and after the study was carried out - 2013 - (Figure 2). The results of the "in loco" survey for land use and occupation (Table 2) show that the following crops predominate at the Watershed: pastures with 30,472 ha, coffee with an area of 2,798 ha, fruit (mango, coconut, and citrus) with 136 ha, eucalyptus with 95 ha, vegetables with 60 ha, passion fruit with 15 ha, crops of annual cycle (corn and beans) with 181 ha, sugar cane with 37 ha and in the environmental condition, natural forest, with 10,606 ha that cover the slopes of the formation known as "Itambe".

Using the images from the Google Earth(r) Pro to verify the effectiveness of the works implanted in the area occupied with pasture with the presence of erosive processes (Figure 2A and 2B), the action of agri-environmental adequacy to contain the erosive processes was implemented and the control of the erosion in the area was accomplished with the construction of containment boxes on areas with pastures. There was an improvement in the visual aspect of the area comparing to soil conservation, in which case it was proven that pasture management with the use of hydraulic structures (containment boxes) favored the restoration of the area and the return of potential soil productivity.

Analysing Figures 2C, 2D, 2L and 2M, it can be seen that the change in management in coffee culture provided a positive change in the landscape, inferring that in addition to improving the landscape with more intense vegetation cover (Figures 2D and 2M), there was an improvement in potential crop productivity. In the coffee culture, what contributed to the improvement of the soil conditions was the adequacy of the crop following the level of the ground and recovery of soil fertility. The soil conservation techniques applied in this case were sufficient to control erosive processes. In Figures 2E and 2G, using the image comparison method, it can be seen that the agricultural terracing built in the area in question was efficient in controlling erosion processes at the property. According to Araujo et al. (2009) the use of appropriate management measures and erosion mitigating actions, with the recovery of the impacted areas, there will be an improvement in water quality and control of sediment production, minimizing silting and consequently, there will be an almost complete environmental rehabilitation. The comparison between aerial images from before (T1) and after (T2) was used to assess the efficiency of the results obtained, a method that was also used by Bezerra et al. (2012) who evaluated by photocomparation the vegetation cover and the potential of water in the soil aiming at the monitoring and recovery of degraded areas in Uberlandia, MG, and considered that the photocomparation with the supervised classification allowed to follow the development of the vegetation cover with grasses, as well as their relation to soil water potential. According to Menezes et al. (2009) with remote sensing, it was possible to verify the presence of areas already affected by inadequate management on areas with degraded pastures. These authors also highlighted the fact that native vegetation has been largely converted into pasture. Figures 2K and 2O, conversely, show the mechanical control of erosions with the construction of dams and terraces that altered the landscape of the place, previously degraded, into a pasture with productive capacity (Figures 2J and 2N). Figure 2J shows an old and eroded road that

carried sediments to the bed of Rio do Peixe and which was corrected by building terraces (Figure 2K). It is important to observe the fact that there are practices focused on the conservation, which represents a large part of the Rio do Peixe Watershed section, besides promoting important benefits for soil conservation, it can be another factor that stimulates the increase in income for producers, once, with conserved pasture, there is a higher volume of biomass and, consequently, the possibility of higher animal density. An example of this statement is the pasture areas recovered with the adoption of the Integrated Crop-Livestock Systems (LIS), where the management of these pastures has changed, replacing the grass variety and providing pasture with good vegetal mass during the dry periods. This resulted in an occupancy rate of five Animal Units (AUs) per ha, as evidenced by the evaluation of 14 properties, wherein 10 of them, there was an average growth of 31% in the occupancy rate, compared to the original situation found before carrying out the inspection work. It corroborates with this information the study of Albernaz & Lima (2007) who evaluated two sub-watersheds, in Lavras, MG, occupied by pastures, according to conservationist practices: level planting, terracing, catchment basins, liming maintenance and inferred that at Ribeirao Santa Cruz sub-watershed (SW) more conservation practices are adopted than at SW Agua Limpa and the exposure of the soil to degradation was bigger at SW Agua Limpa. A similar result was observed by Zolin et al. (2011) stating that the biggest relative reductions in soil loss occurred on scenarios with conserved pasture, indicating that the optimization of soil conservation can be accomplished by adopting conservationist management practices for pasture recovery. According to Rodrigues et al. (2015) who analysed the role of vegetation in water interception and erosion control, at Rio Paraiso Watershed, in Sao Manuel, SP, the uncovered soil showed a 98.09% increase in sediment production, when compared to soils with vegetation cover.

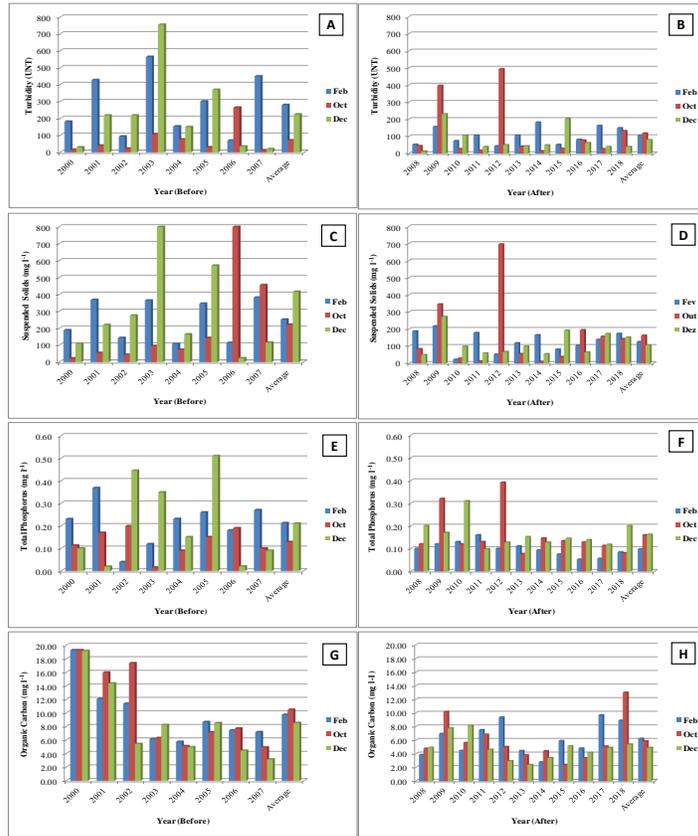
The improvement in water quality caused by the control/minimization of erosive processes and sediments carried to the watercourse were confirmed by the water quality indicators: Turbidity, Suspended Solids, Phosphorus and Organic Carbon, analysing the representative graphics the results of these analyses (Figure 3). The Turbidity of the water evaluated from 2000 to 2007, considered as before the work was carried out (BEFORE - T1), presented average values of 192 NUT (Nephelometric Units of Turbidity), against the average values of 102 NUT, evaluated from 2008 to 2018, considered as after the completion of the study (AFTER - T2), a decrease of 53% in the average values. The suspended solids evaluated from 2000 to 2007 (T1), presented average values of 297 mg l-1 (milligrams per litre), against the average values of 132 mg l-1, evaluated from 2008 to 2018 (T2), a 44% drop in average values. The phosphorus evaluated from 2000 to 2007 (T1), presented average values of 0.18 mg l-1 (milligrams per litre), against the average values of 0.14 mg l-1, evaluated from 2008 to 2018 (T2), a 78% drop in average values. The Organic Carbon evaluated from 2000 to 2007 (T1), presented average values of 9.60 mg l-1 (milligrams per litre), against the average values of 5.19 mg l-1, evaluated from 2008 to 2018 (T2), with a 59% drop in average values. (Vischi Filho

Analysing the turbidity data, suspended solids, phosphorus and dissolved organic carbon (Figures: 3 - A, B, C, and D), it ensures that the data from treatment T2 are more uniform or stable than in T1 for these indicators. When analysing Figures 3A and 3B, related to water turbidity, in previous years the implementation of the study (T1) and after the implementation of the study (T2), it observes that, on average, water turbidity was lower in the months of February and December when we compare (T2) with the situation before the implementation of the study (T1). For the T1 treatment, the values were higher than the CONAMA standard (Conama, 1986), which is 100 NUT (Figure 3A), in the average of February and December. In T2 treatment, the average values were 102 NUT, except for February 2009, 2014, 2017 and 2018; October 2009, 2012 and 2018; December 2009 and 2015 (Figure 3B). This difference seen in T2 can be explained by the decrease in the supply of sediments in the watercourse. It happened because of the effects of the change in soil management with the adoption of conservationist practices and erosion control through the implementation of technical projects at the 196 properties that were recovered with conservationist agriculture, through the work performed (Figures 3B, 3D, 3E, 3G, 3I, 3K, 3M and 3O). A similar result was found by Souza & Gastaldini (2014), who observed that land use significantly influenced the water quality parameters. In areas considered to have a higher percentage of agriculture and with problems related to erosion, the situation of the area before the implementation of constructions, the parameters of turbidity, suspended solids are higher. This land use, without adopting conservationist practices, can be considered as having the biggest potential for erosion.

As for suspended solids, the highest values were recorded in T1 treatment (Figure 3C) compared to T2 (Figure 3D), in February all values were bigger than 100 mg l-1 (milligrams per litre), with an average of

252 mg l<sup>-1</sup> for that month. The same happened with the values of October 222 mg l<sup>-1</sup> and in December with an average of 416 mg l<sup>-1</sup>. In T2, the values were more uniform, with averages of 126, 163 and 107 mg l<sup>-1</sup>, only with a peak of 696 mg l<sup>-1</sup> observed in October 2012 (Figure 3D), however, it was still below the peaks recorded in the T1 in October 2006, which was 884 mg l<sup>-1</sup> and the peak observed in December 2003 with 1850 mg l<sup>-1</sup> (Figure 3C). The results of suspended solids for the rainy season were lower than those described by Setzer (1985) who evaluated soil losses and their relation to turbidity and water parameters in several watershed in the state of Sao Paulo and inferred that the averages annual rates for suspended solids in the rivers of Sao Paulo are slightly less than 150 mg l<sup>-1</sup>, rising to almost 300 mg l<sup>-1</sup> in the rainiest months and lowering to less than 50 mg l<sup>-1</sup> in the driest months. The results of the study show that there was a significant decrease in suspended solids after the adoption of conservationist practices and the rehabilitation of agricultural properties. Rodrigues et al. (2015) evaluated that the runoff coefficient was low in the presence of vegetation resulting in bigger infiltration and better flow regularity and that erosion and carried sediments increased on unprotected soils, changing the dynamics of water on the soil.

The total phosphorus dissolved in water in T1 (Figure 3E), presented values higher than those recommended by CONAMA Resolution 20/86, which is 0.025 mg l<sup>-1</sup>, compared to T2 (Figure 3F). The values of phosphorus for T2 of 0.10, 0.16 and 0.16 mg l<sup>-1</sup>, for February, October, and December, respectively, were below the values of 0.21, 0.13 and 0, 21 mg l<sup>-1</sup>, except for October, the values observed in T1 were higher than those recorded in T2, except for the peaks recorded in December 2010 and October 2009 and 2012, which reached more than 0.30 mg l<sup>-1</sup>, even below the peaks that occurred in T1 in 2001, 2002, 2003 and 2005, which reached 0.50 mg l<sup>-1</sup>, in December 2005 (Figure 3E). The results show lower values than the values obtained by Donadio et al. (2005) who evaluated the water quality in a Watershed in Taquaritinga, SP, whose predominant soil is the Ultisol and the average values of phosphorus in the water for the dry period of the year was 1.58 mg l<sup>-1</sup> and for the rainy season was 4.32 mg l<sup>-1</sup>. The results of phosphorus, found by Pinheiro et al. (2014), who studied the use and occupation of soil and the relation to water quality in two sub-areas of Rio Duas Mamas Watershed in Santa Catarina, were 27.3 and 41.6 mg l<sup>-1</sup> and, were higher than the results found in the present study. This was because in SW2 there were banana cultivation and cultivation areas for annual cycle crops, despite the large percentage of remaining natural forest, in both cases.

As for the organic carbon dissolved in water (C), the data were higher in T1 with averages of 9.76, 10.50 and 8.55 mg l<sup>-1</sup>, in all months of February, October and December respectively, reaching values of C above 19 mg l<sup>-1</sup> in 2000. In treatment T2, the average carbon values of 6.25, 5.88 and 4.90 mg l<sup>-1</sup>, for the same months, were between 4.9 and 6,2 mg l<sup>-1</sup> while at T1, they were between 8.5 and 10.5 mg l<sup>-1</sup> (Figure 3G). It ensures that the amount of C in the water after the implementation of the project was lower than the situation before the implementation of the project, in this case, the conservationist practices implemented contributed to a smaller amount of eroded sediments, a result that corroborates with Silva et al. (2005) that in their study the organic C was the constituent found in bigger quantity in eroded sediments, emphasizing the need for conservationist practices that reduce the erosive action of rain, maintaining this organic fraction in the soil.
