Clear Demonstration of Different Mechanisms of Severe Mitral Regurgitation Caused by the Mitral Ring Dehiscence during Transesophageal Echocardiography

Abstract

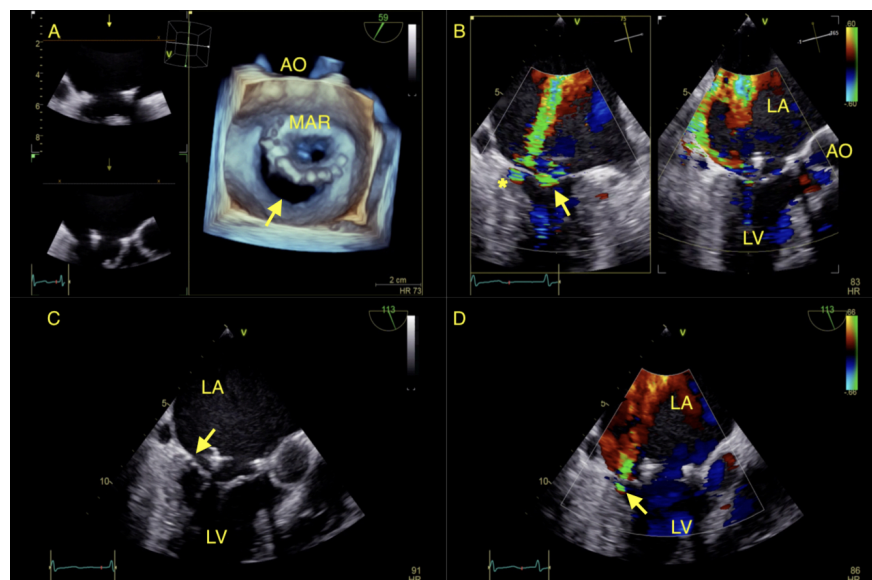
Figure Legends

Figure 1a: Three-dimensional transoesophageal echocardiography (TEE) imaging of the mitral ring dehiscence.

Figure 1b: The first jet was originating from the perimitral ring(arrow) and the second jet(asterisk) was arising from the basal portion of the posterior mitral leaflet.

Figure 1c: Image of the defect in the basal portion of the posterior mitral leaflet in the mid-esophageal TEE view.

Figure 1d: Rise of the mitral regurgitation jet from the defect in the basal portion of the posterior mitral leaflet possibly occurred after the separation of mitral ring suture.

of the mitral ring to the basal portion of the PML in the previous surgery may cause a predisposition to ring dehiscence, and the suture site on the PML behaved as an independent source of MR besides the regurgitation jet from the perimitral ring. In this case, two- and three-dimensional echocardiographic demonstrative images are presented to highlight this rare clinical condition.
