Cardiac tamponade with pneumothorax- An unusual life threatening complication following permanent pacemaker implantation.

Abstract

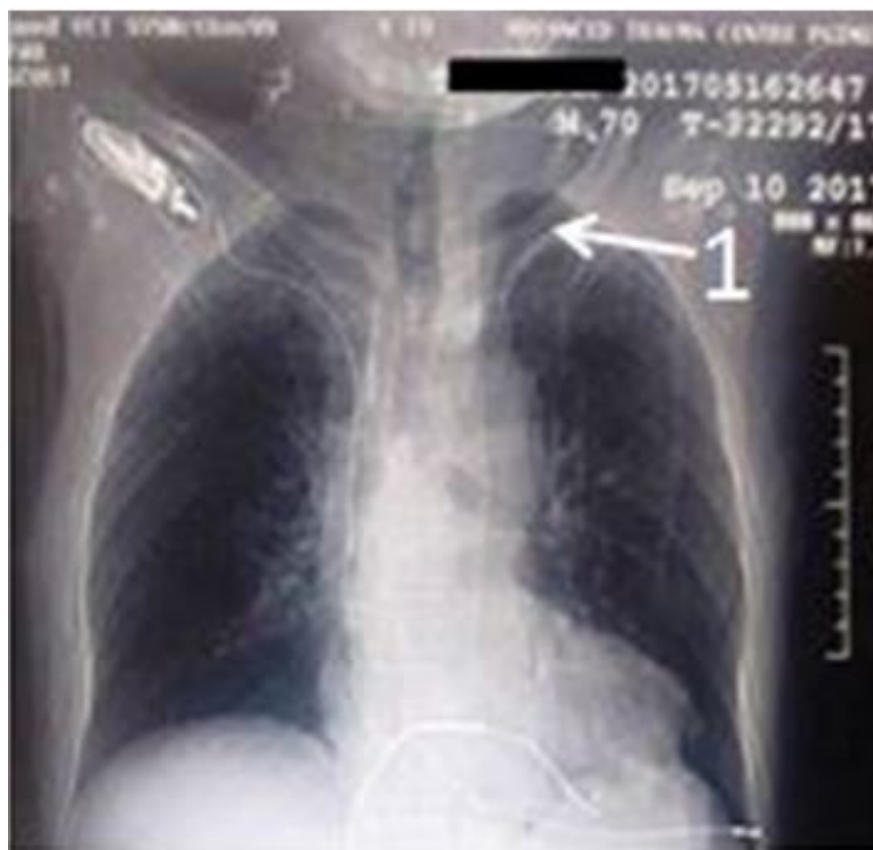
Figure1

Chest x ray showing PPI out of cardiac silhouette and its tip in left hemithorax causing

pneumothorax.

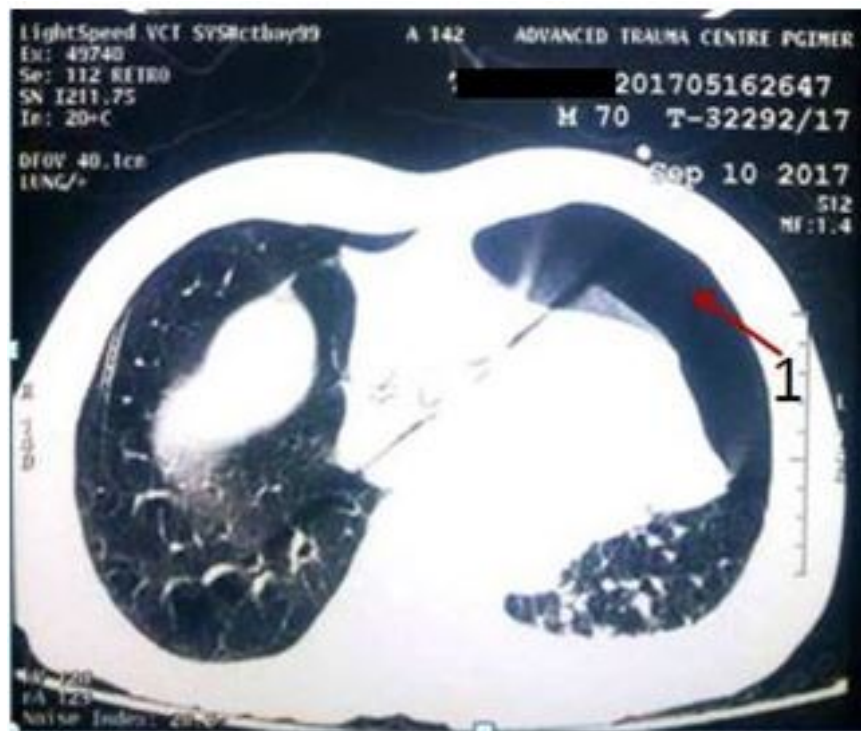
Figure 2

Computer tomography of chest showing collapsed left lung due to pneumothorax.

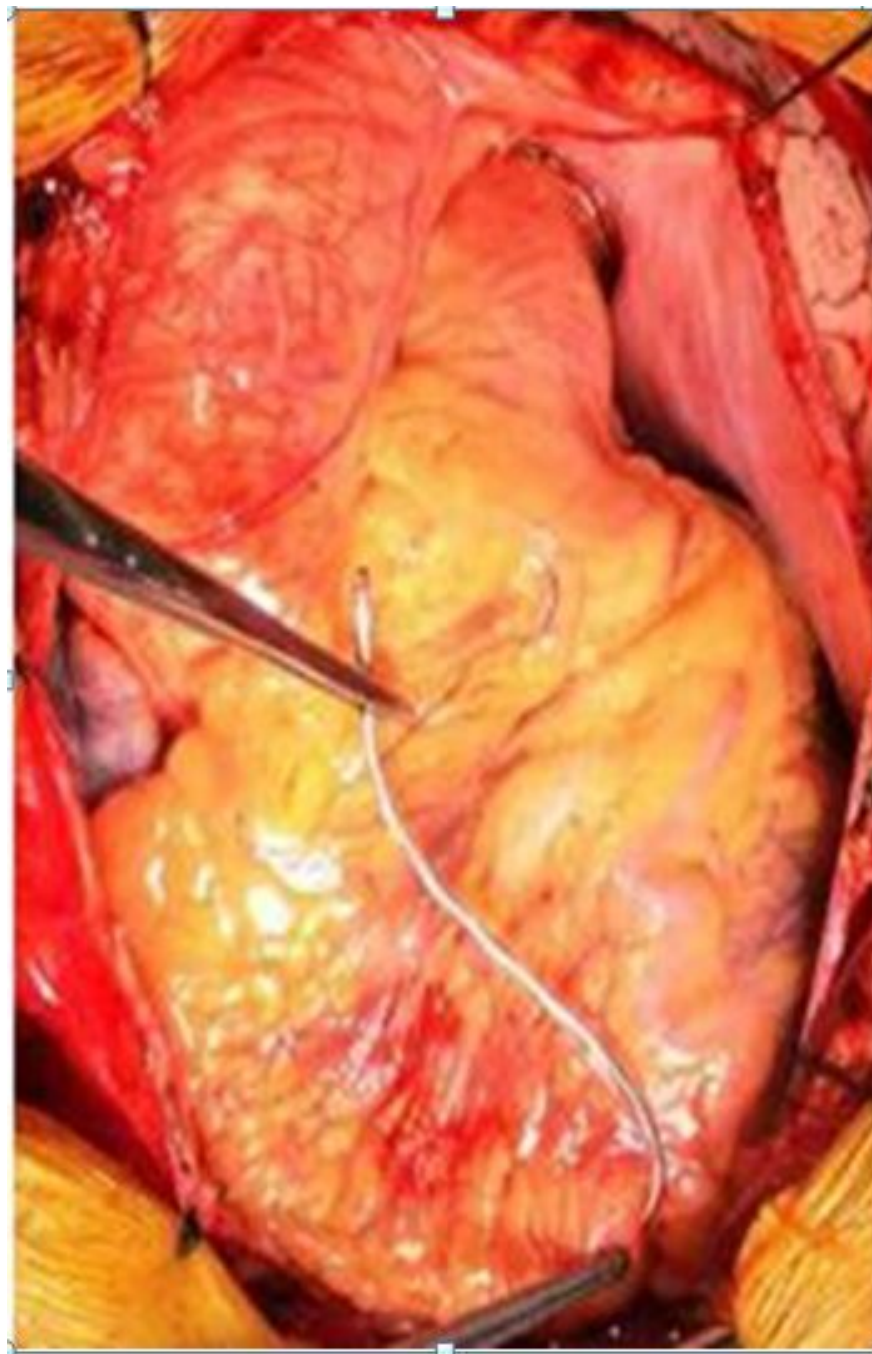
Figure 3

Intra-operative finding showing PPI lead perforated the right ventricular apex(shown with a pair of forceps).
