# Valvular Complications Following the Impella Device Implantation

## Abstract

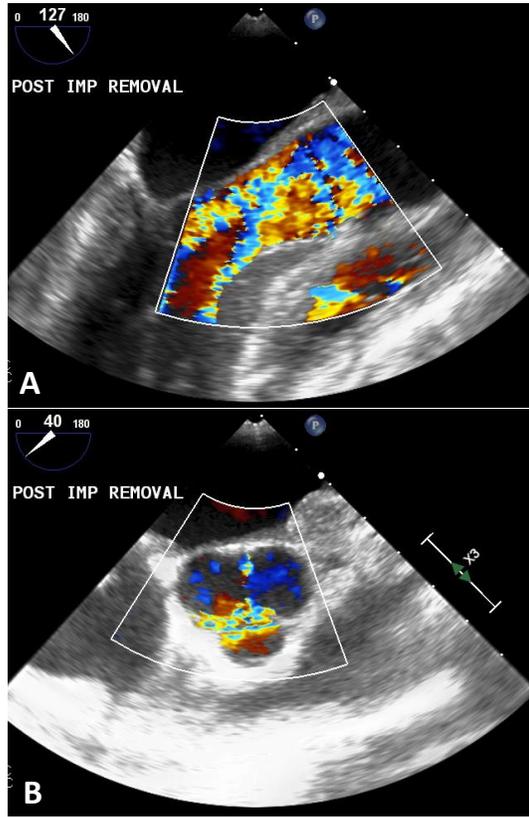
**FIGURE 1.** Intraoperative transoesophageal echocardiogram: A - immediately after removal of the Impella

CP, midesophageal aortic valve long axis view, and B - midesophageal aortic valve short axis view. Figure 1A shows the same view with severe aortic regurgitation despite removal of the Impella device. Nearly complete right coronary cusp injury is visualized in the Figure 1B. Written informed consent to publication was provided by the patient.

Iatrogenic injury of the aortic valve (AV) is a potential complication related to the Impella resulting in significant aortic valve regurgitation (AR) (Figure 1). There are various contributing factors that can be considered that may lead to AR (Table 1). Recent studies have described several mechanisms that can cause injury of the AV during the implantation, repositioning, and removal of the Impella device [14-16]. The aortic valve might be damaged by the stiff guidewire during the insertion or with the Impella device itself following the guidewire going through the leaflet. Alternatively, improper handling of the device such as insertion across the aortic valve without the guidewire or without echocardiographic guidance might be one of the mechanisms. In addition, direct contact of the inlet during repositioning or removal of the Impella might damage the valve due to the effect of suction if the flow is not reduced as per guidelines. Severe AR caused by aortic valve injury may necessitate further treatment such as aortic valve replacement or transcatheter aortic valve intervention. It is important to distinguish AR caused by commissural malcoaptation of the two leaflets related to the device, which might improve after its removal [17]. AR can be challenging to detect with echocardiography because of the artefacts generated by the device [15]. Importantly, a recent observational study has demonstrated that even after short-term Impella support, a significant proportion of patients may develop progression of AR [18]. The authors have observed this complication in 9 patients despite an extremely short support duration in their cohort (median less than 1 day) [18]. However, the causality of AR and follow-up of these patients were not investigated.
