Transillumination: No one outwits me

Javier Ivan Armenta-Moreno¹, Joaquin Berarducci^{1*}, Nilda Espinola-Zavaleta^{1,2}

Short Title: Prosthetic valve endocarditis

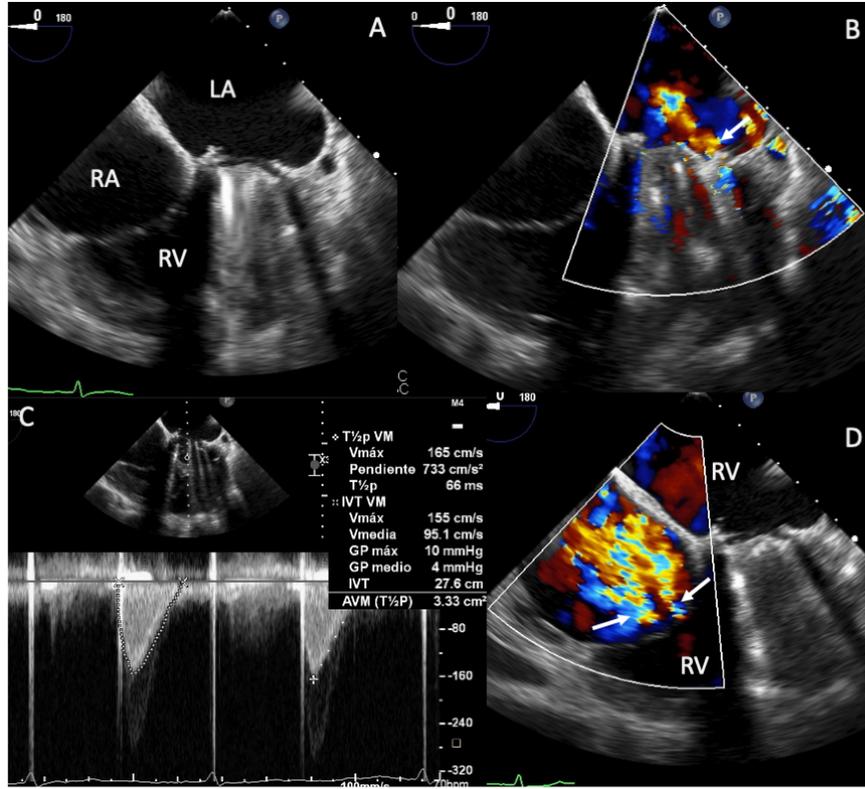
Figure 1. 2D transesophageal echocardiography in four chamber view with continuous wave and color flow. A: Prosthetic mitral valve without vegetations in the atrial view and dilation of right cavities. B: Paravalvular leak (white arrow). C: Prosthetic valve area 3.3 cm² and mean gradient 4mmHg. D: Two jets of tricuspid regurgitation (white arrows). Abbreviations: RA-right atrium; RV-right ventricle; LA-left atrium.

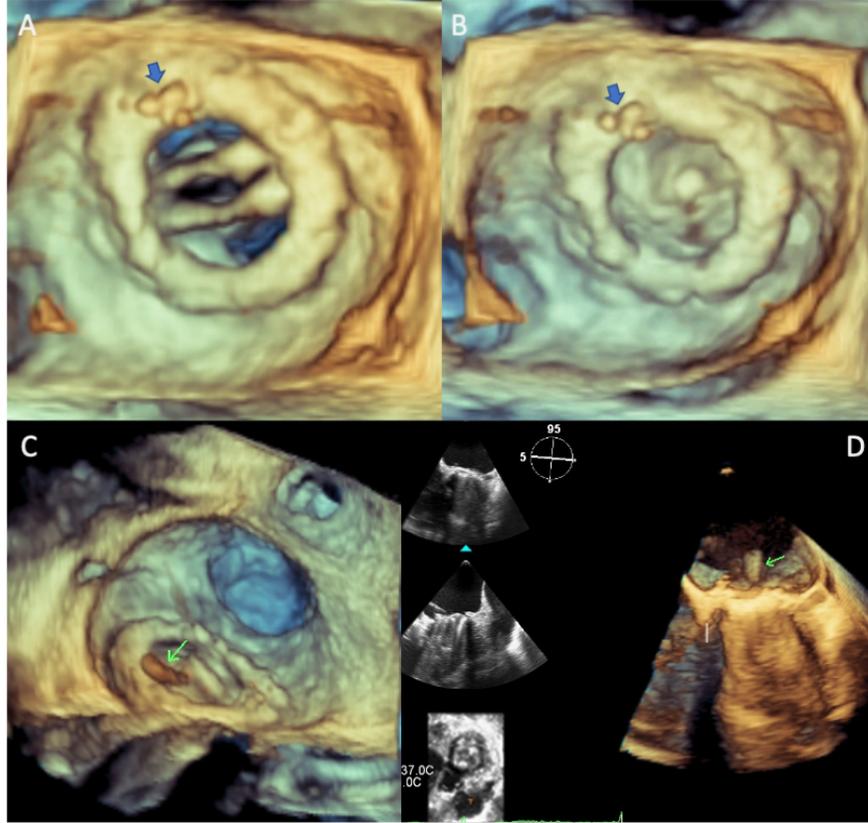
Figure 2. 3D transesophageal echocardiography. A: Atrial view of the mitral prosthetic valve in diastole (blue arrow pointing surgical suture) B: Atrial view of the mitral prosthetic valve in systole. C, D: Atrial view of the prosthetic mitral valve with evidence of a mass (green arrow).

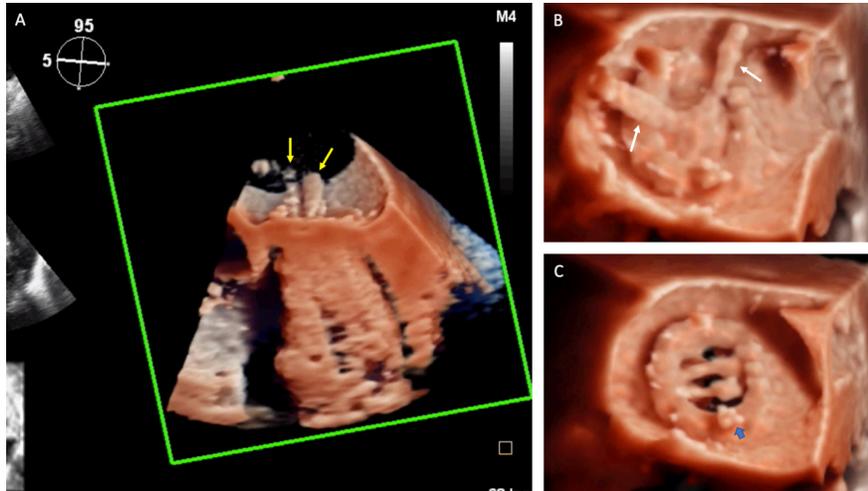
Figure 3. 3D transesophageal echocardiography with transillumination. A: yellow arrows showing vegetations in the atrial view of mitral prosthetic valve. B: Surgical view of mitral prosthetic valve during systole with evidence of vegetations (white arrows). C: Surgical view in end diastole presenting surgical suture (blue arrow)

Transillumination is widely recommended due to a better anatomical and functional definition, characterization and diagnosis of cardiac lesions compared to traditional echocardiographic methods. This technique allowed us to precisely diagnose the vegetations that were not visualized with routine echocardiographic methods; highlighting its usefulness in patients with prosthetic valve endocarditis.
