Crack path and regularities for ball-bearing fracture in the very high cycle fatigue regime

Andrey Shanyavskiy¹ and Aleksey Soldatenkov¹

March 3, 2022

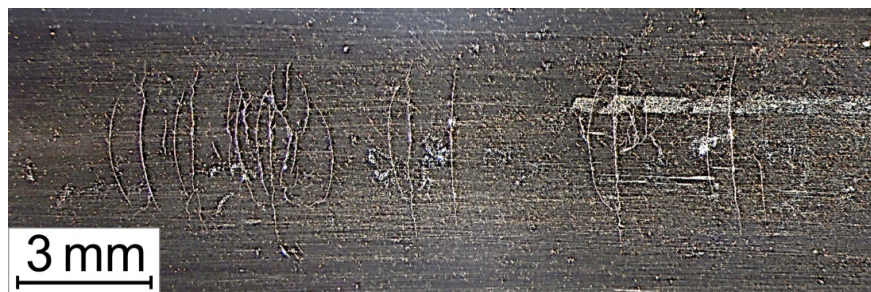
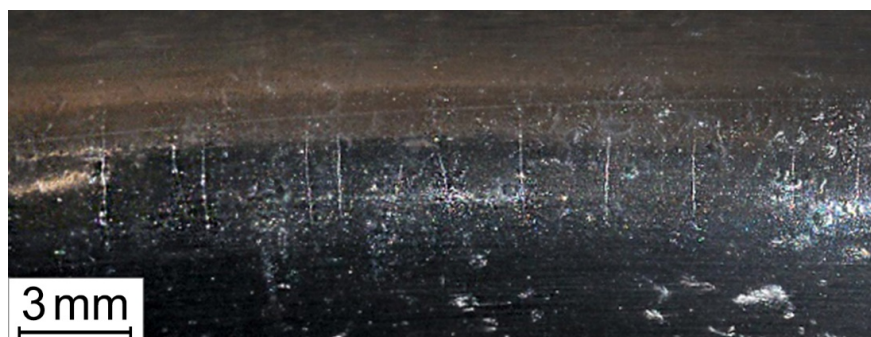
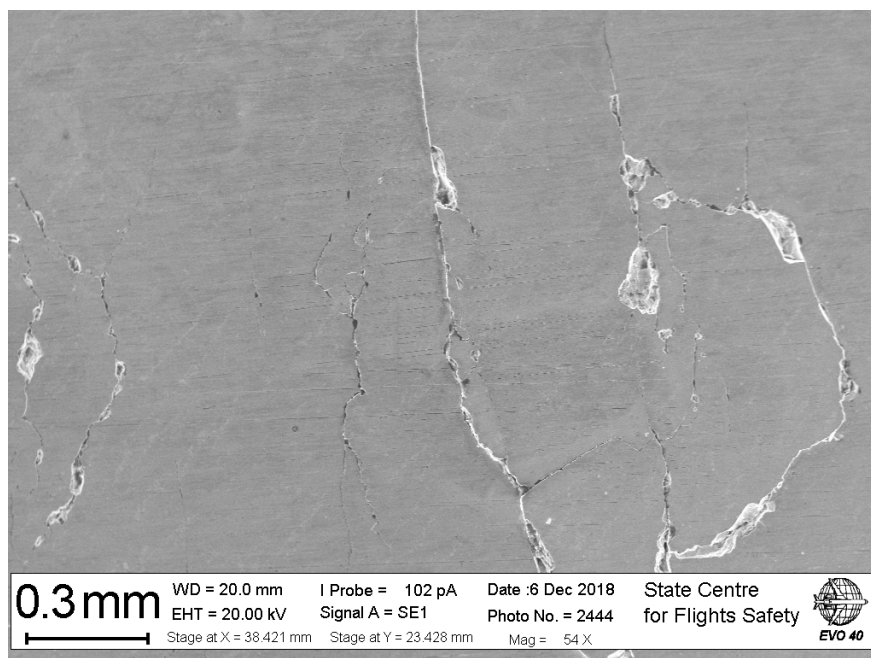
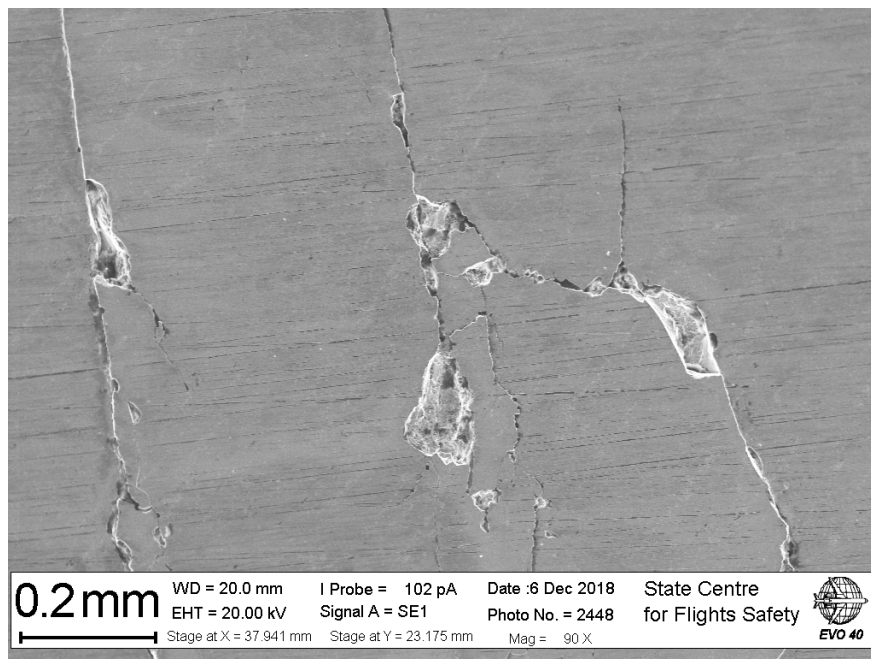
When the fault detection of bearings was performed, cracks were found on the raceway surface of the bearing rings (Fig. 1). The cracks were oriented perpendicular to the direction of ball movement. As well, several zones of developed material fatigue spalling process were revealed (Fig. 1 c, d).

Fig. 1. Cracks of outer ring raceway in ball bearings (a) 76-211R and (b) 5-126215R, and (c, d) small fatigue spallings in the regions of crack coalescence at different magnifications.

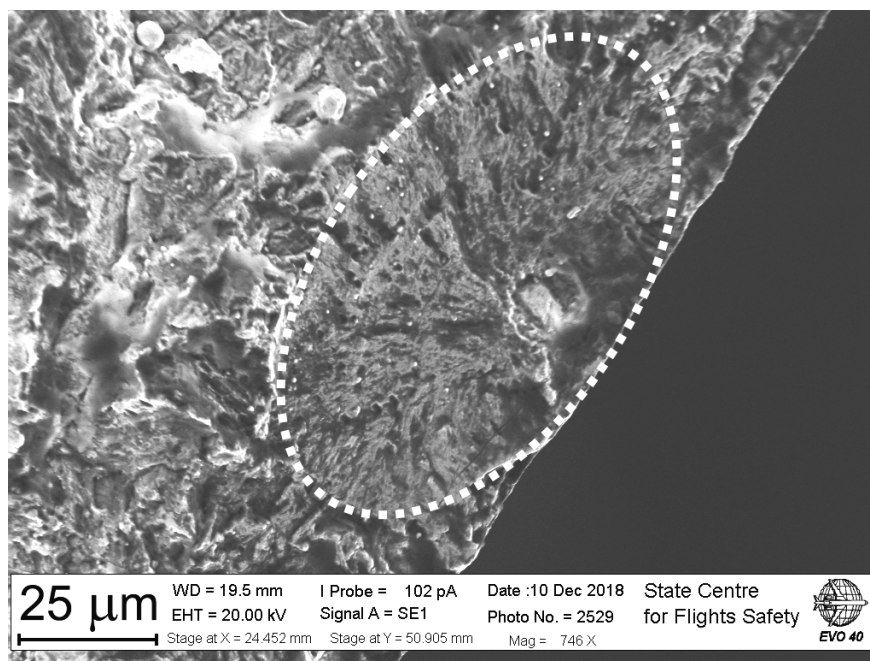
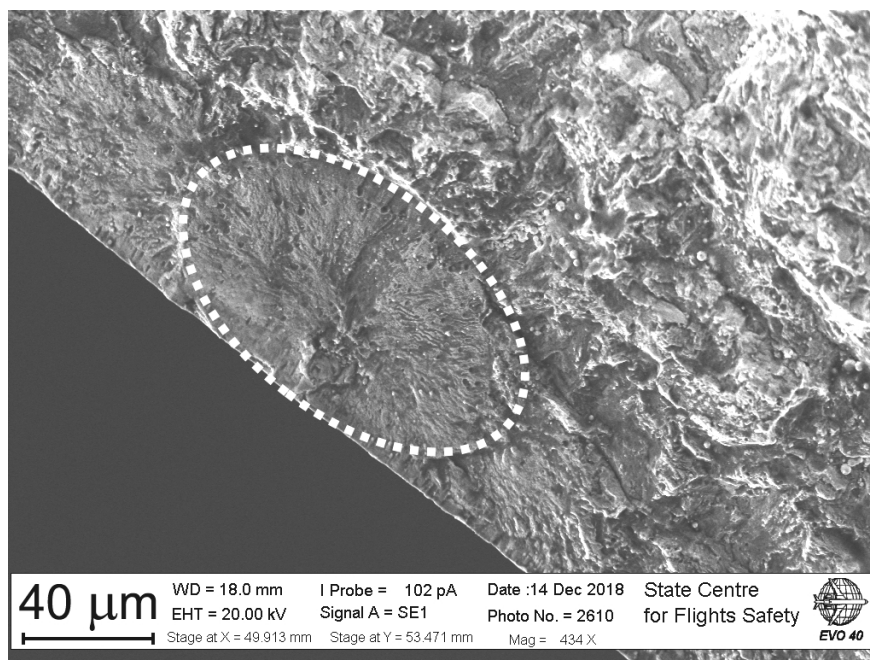
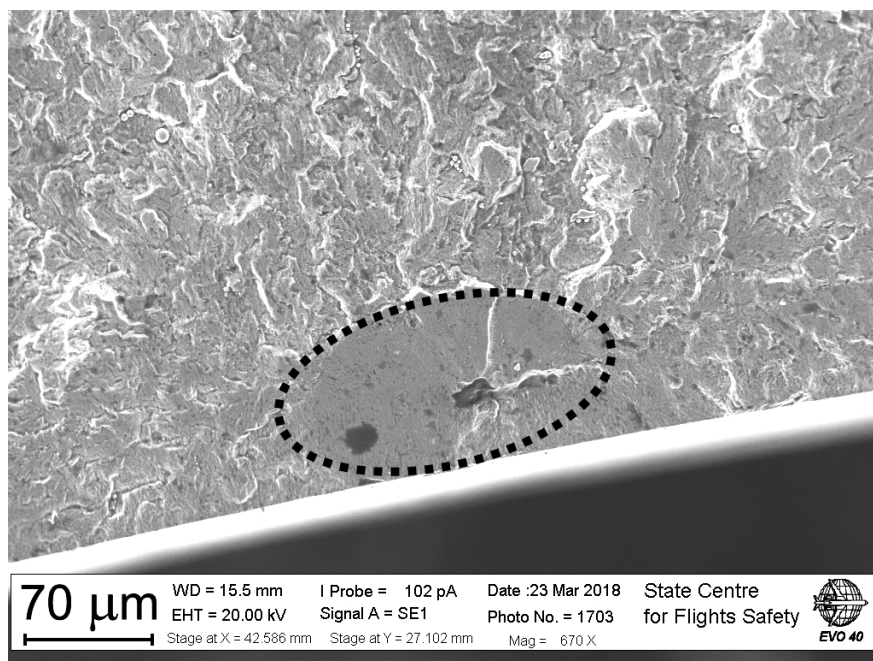
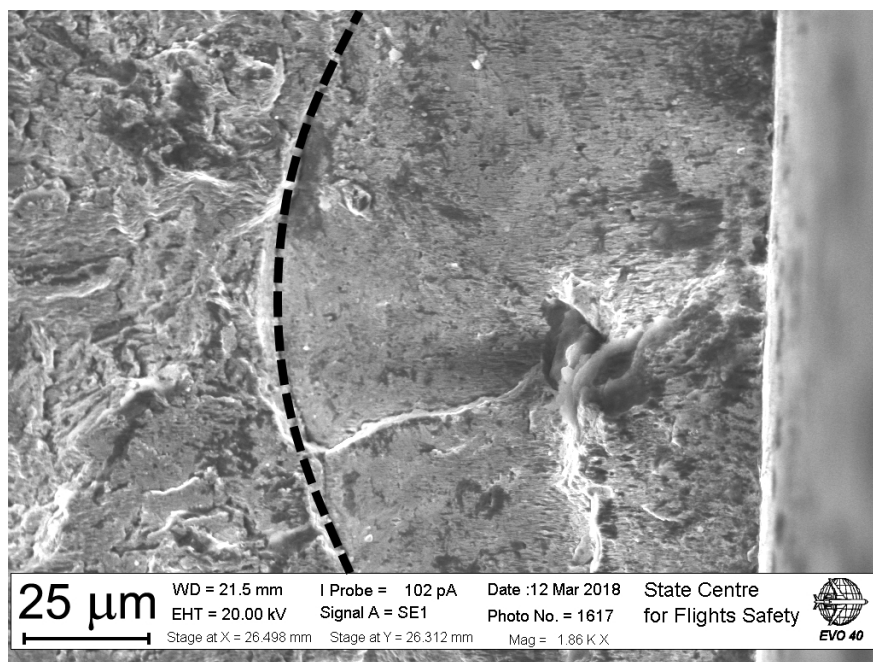
The first group consists of cracks with a subsurface origin (Fig. 3). The shape of the initial crack development zone is evidenced that it was formed without the crack emerging onto the raceway surface. In the focus of the origin, a particle, being a stress concentrator, is located. The second group of cracks, oriented perpendicular to the direction of the ball movement, consists of cracks that had not revealed a pronounced fracture origin, although, in some regions of the fracture surface near the raceway surface, smooth semi-elliptical zones formed into a small depth are observed (Fig. 4).

The detected inclusions in the origins of subsurface cracks are located at a depth of 10-15 μm and 30-40 μm from the raceway surface in the ball bearings 76-211R and 5-126215R, respectively. The nature of the inclusions was determined using local X-ray analysis. It was established that the content of such elements as C, V, and W in the composition of the particles is significantly higher in comparison with the content of the elements outside the particles for bearing 76-211R (Fig. 5). The content of Fe within the particles is almost an order of magnitude lower than outside them. Therefore, the particles can be identified as angular carbides that are inherent in the bearing material under investigation and are not defects of the manufacturing procedure. The sizes of angular carbides in the focus of subsurface fracture origins do not exceed the values allowed by the documentation regulating the material of bearing rings. The particles in the origins of subsurface cracks in the bearing 5-126215R are composed of such elements as S and Al, i.e., chemical elements that are material contamination. Thus, it was established that the subsurface crack initiation in the bearing occurred from particles in the form of sulphide and aluminium inclusions, which, unfortunately, cannot be eliminated in the technology of steel production.

Fig. 3. Subsurface crack origins in outer rings for ball bearings (a, b) 76-211R and (c, d) 5-126215R.

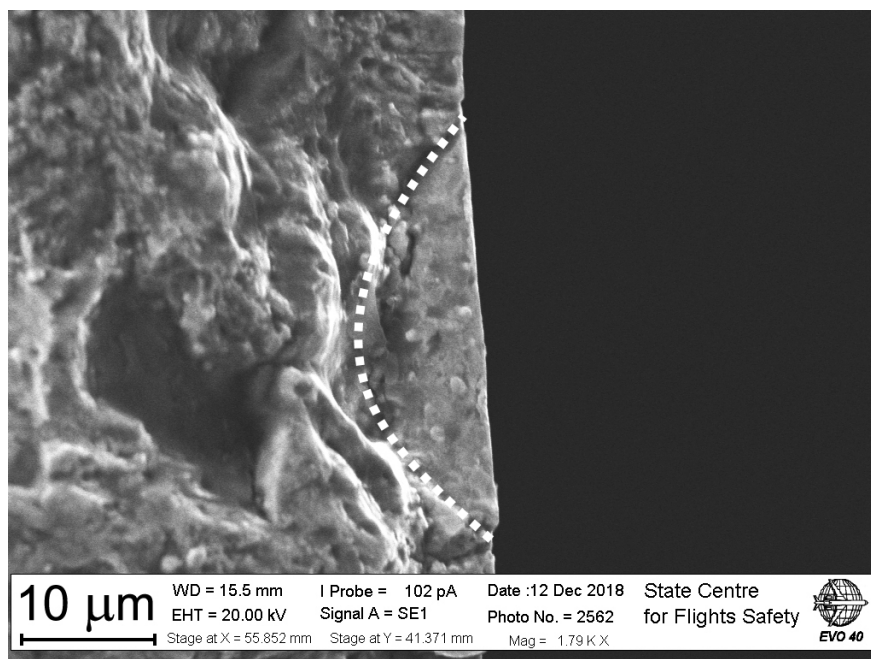
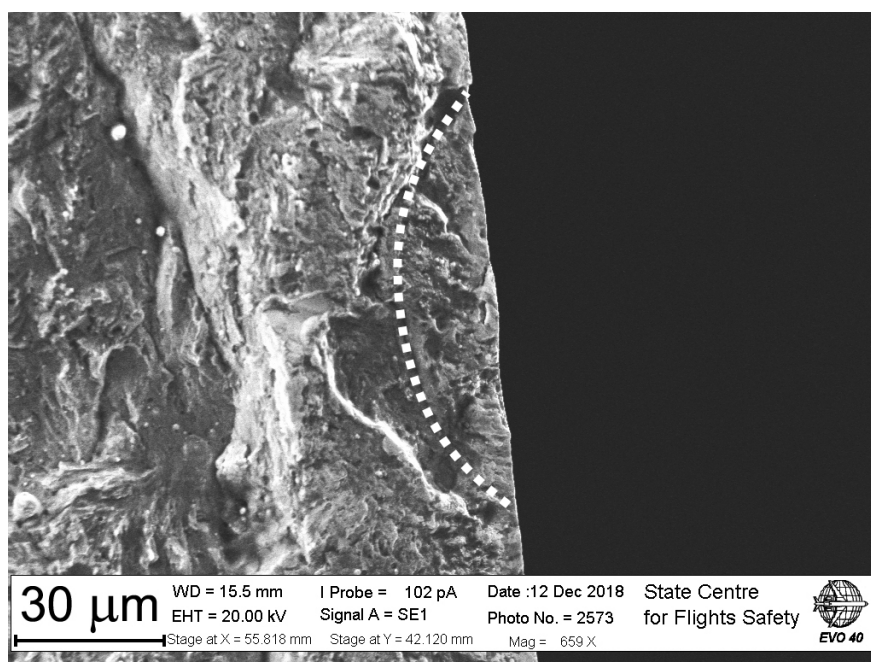
Fig. 4. (a, b) Surface crack origins in outer rings of ball bearings.

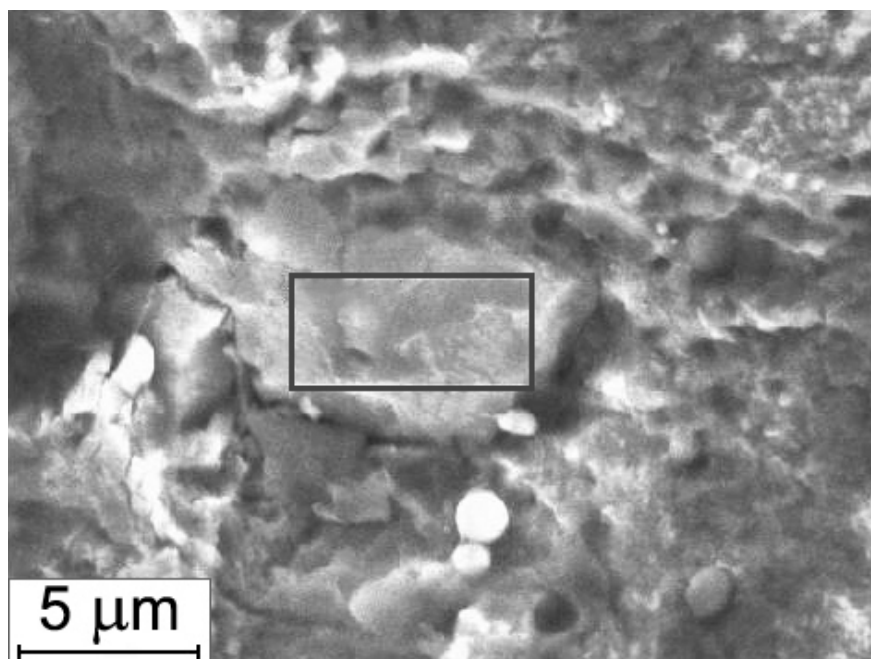
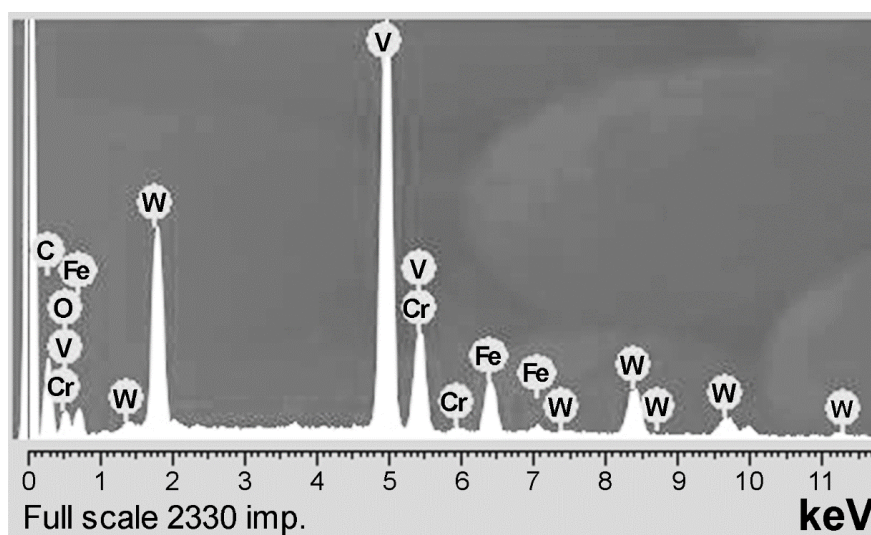
The geometry of the initial crack development zone almost coincides with the already classical shape of the origination zone formed in the VHCF regime ("fish-eye"). However, the observed zone in the bearings has an elliptical rather than circular shape, and the major axis of the ellipse is almost parallel to the raceway surface. The contact effect of the ball on the raceway, combined with the stress concentration generated by the particle, has a decisive influence on the subsurface initiation of a fatigue crack.

Fig. 5. (a) Inclusion as angular carbide in the focus of subsurface crack origin in the outer ring of bearing 76-211R and (b) the corresponding spectrum of the chemical element distribution over the rectangular area indicated in (a).

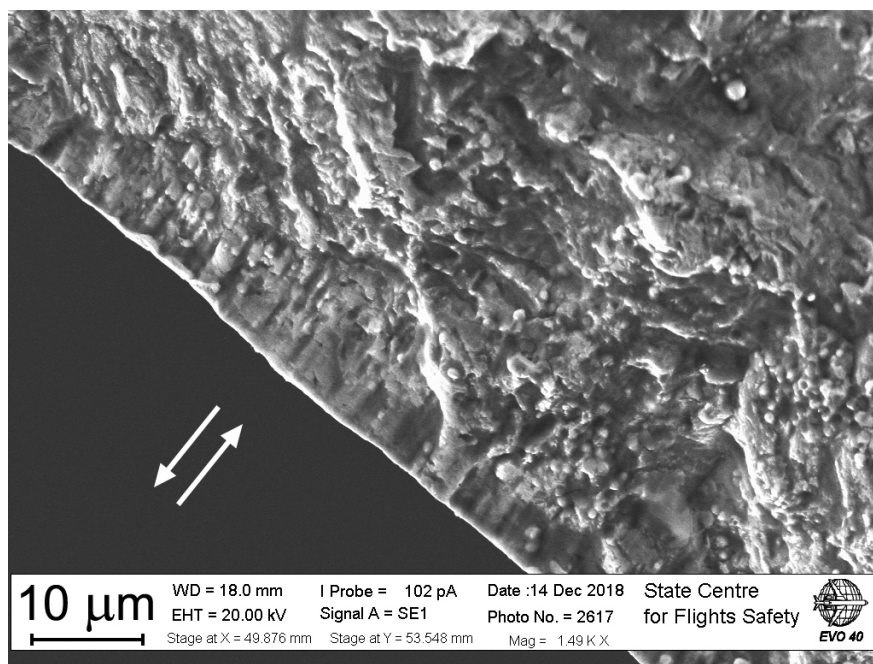
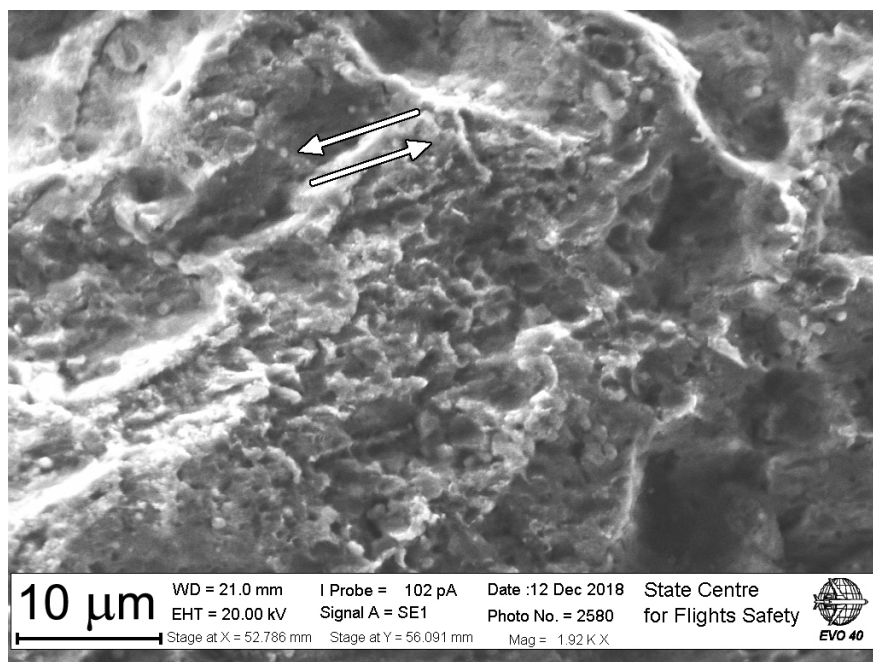
The in-depth crack propagation outside the zone of the fracture origin was accompanied by the formation of relief with numerous slip planes, regions of intergranular fracture, and a cascade of rivers-like relief. It is worth noting that even in these regions of the fracture surface, the zones with grooves of the spherical carbide movement due to their pressing into the matrix under shear conditions are observed (Fig. 6b).

Fig. 6. The grooves from the spherical carbide displacements on the fracture surface (a) at the raceway surface and (b) in the depth of ring material under mixed-mode loading conditions due to the ball pressure. (The arrows indicate the direction of the crack face displacement.)

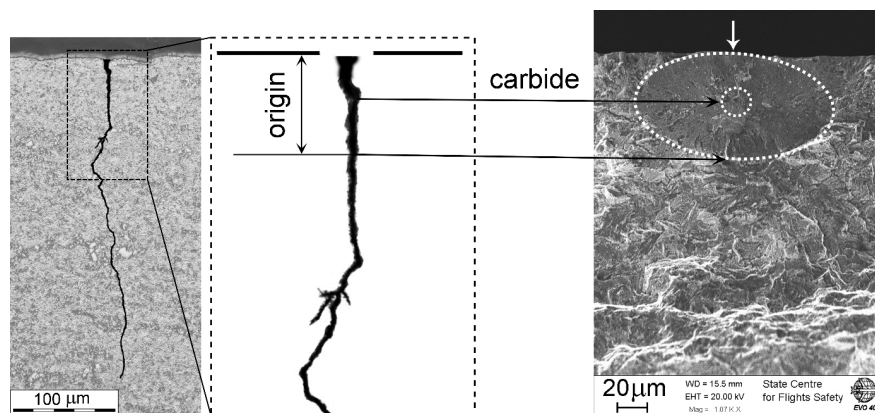
The paths of rectilinear cracks formed initially perpendicular to the direction of ball movement, together with the curvilinear cracks adjacent to them, were studied in several radial sections on the slices of the ring material passing through the raceway surface. It was established by the metallographic analysis of the slices that the initial crack growth in the depth of the material occurs in a plane almost perpendicular to both the raceway surface and the direction of ball movement. The cracks originate from inclusions located at a certain distance from the raceway surface (Fig. 7).

Fig. 7. The crack path at the initial stage of almost vertical crack growth observed in the radial section of the outer ring of the bearing along with the initial crack propagation zone on the fracture surface obtained from the crack previously studied on the slice. (The white arrow indicates the direction of the ball pressure.)

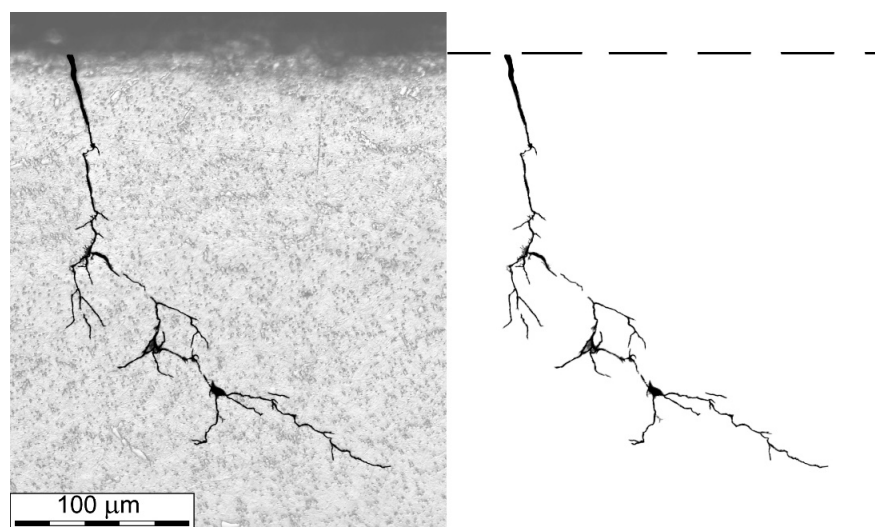
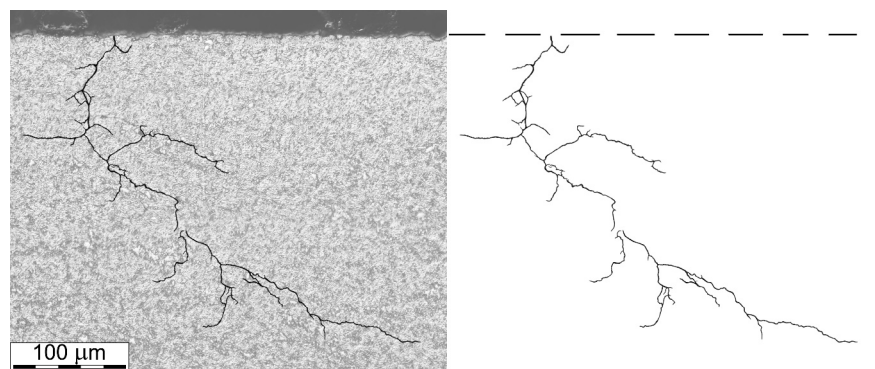
The successive crack development is accompanied by its multiple branching and a gradual transition to propagation by one of the most developed branches along the raceway surface (Fig. 8). It is worth noting

Fig. 8. Crack path with brunching (a, b) observed in radial sections located at different distances from the middle line of the outer ring raceway.

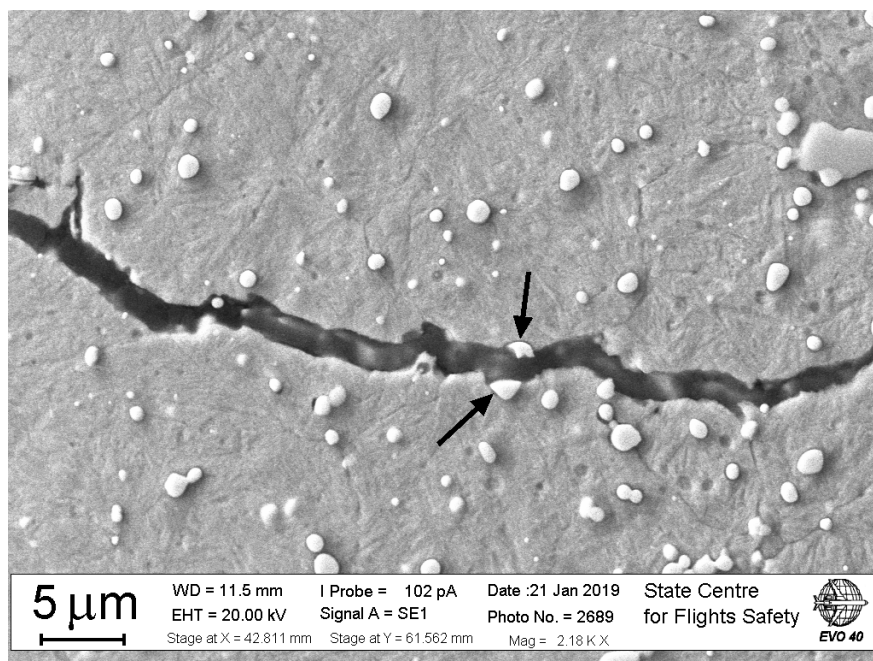
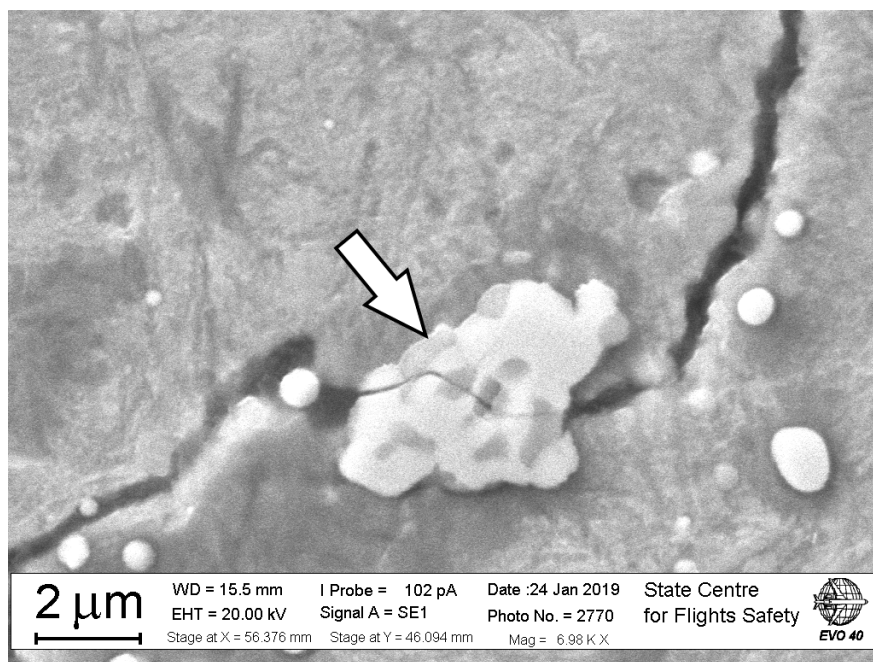
that during its growth, the crack intersected the carbides by fracturing them or passed by if the cohesion between carbide and base material is insufficient (Fig. 9).

Fig. 9. The intersection of (a) spherical and (b) angular carbides during crack growth.

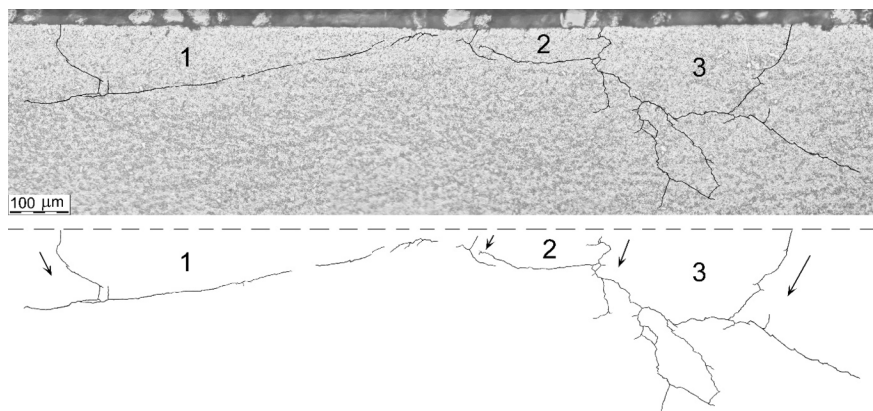
After increasing crack length up to a certain value in a direction almost parallel to the raceway surface, the coalescence with an adjacent crack that has developed in-depth of ring occurs, or the crack turns independently towards the raceway surface (Fig. 10). The crack coalescence does not take place along the total length of the crack front. Part of the crack front remains independent, therefore in some sections, a fragment of the crack path without emerging the raceway surface and without connecting to an adjacent crack can be observed. When analyzing the sections, which are located closer to the middle of the raceway, the already existing connection between the fragment of the adjacent crack fronts is revealed (Fig. 10).

Fig. 10. Coalescence of adjacent branching cracks with the formation of material fragments (areas 1 to 3) for their subsequent separation at the initial stage of the fatigue spalling process. (The arrows indicate the growth direction for the initial propagation of cracks.)
